# Repair of the Bertrand Lens Focus Control Wire Leitz Orthoplan FSA-50 Pol-Photo Tube

Michael Cox  
March 01, 2014

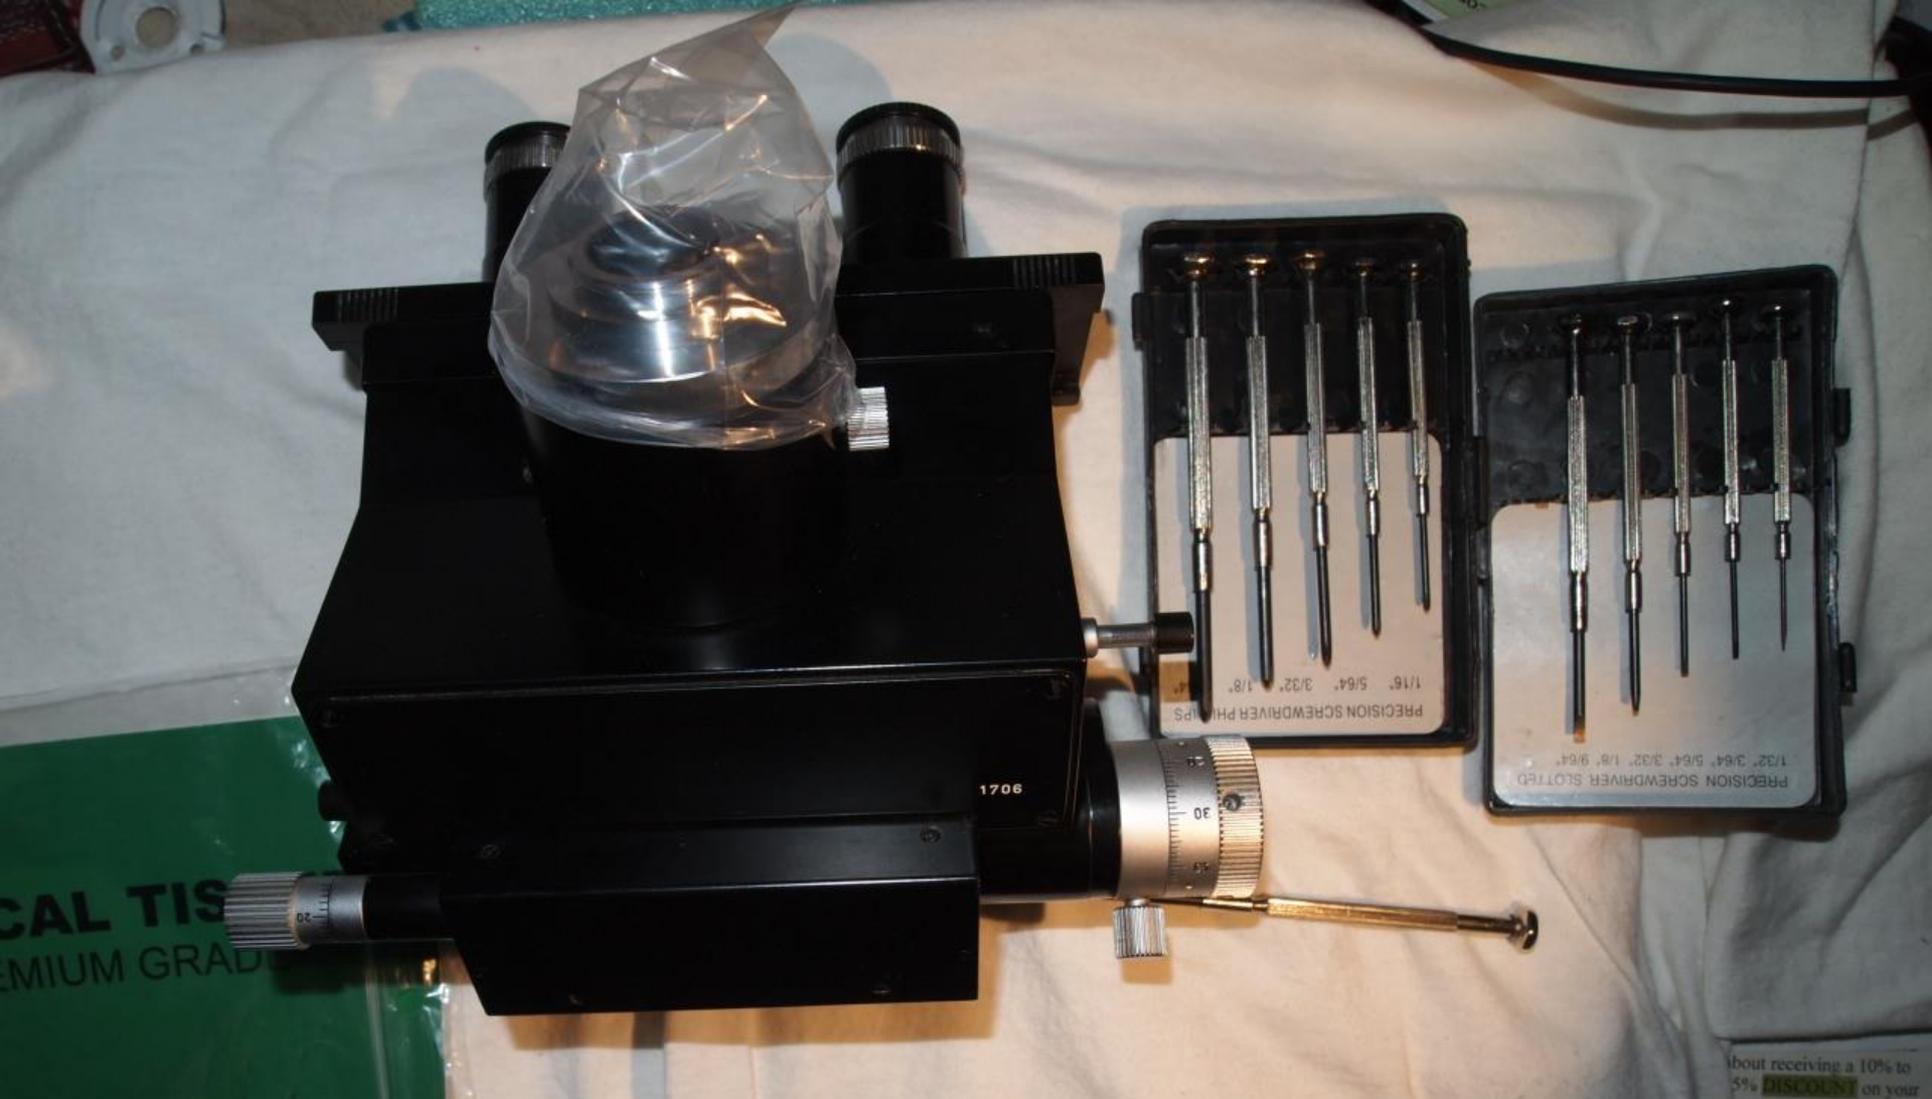
Tube on clean cotton cloth, ready for repair. Tools, cleaning supplies, and magnets at the ready. Before working, take a trip to your local camera shop to get lint-free cleaning supplies. Have a can of compressed gas for blowing off dust and lint. Make sure it is safe for coated microscope lenses and parts.

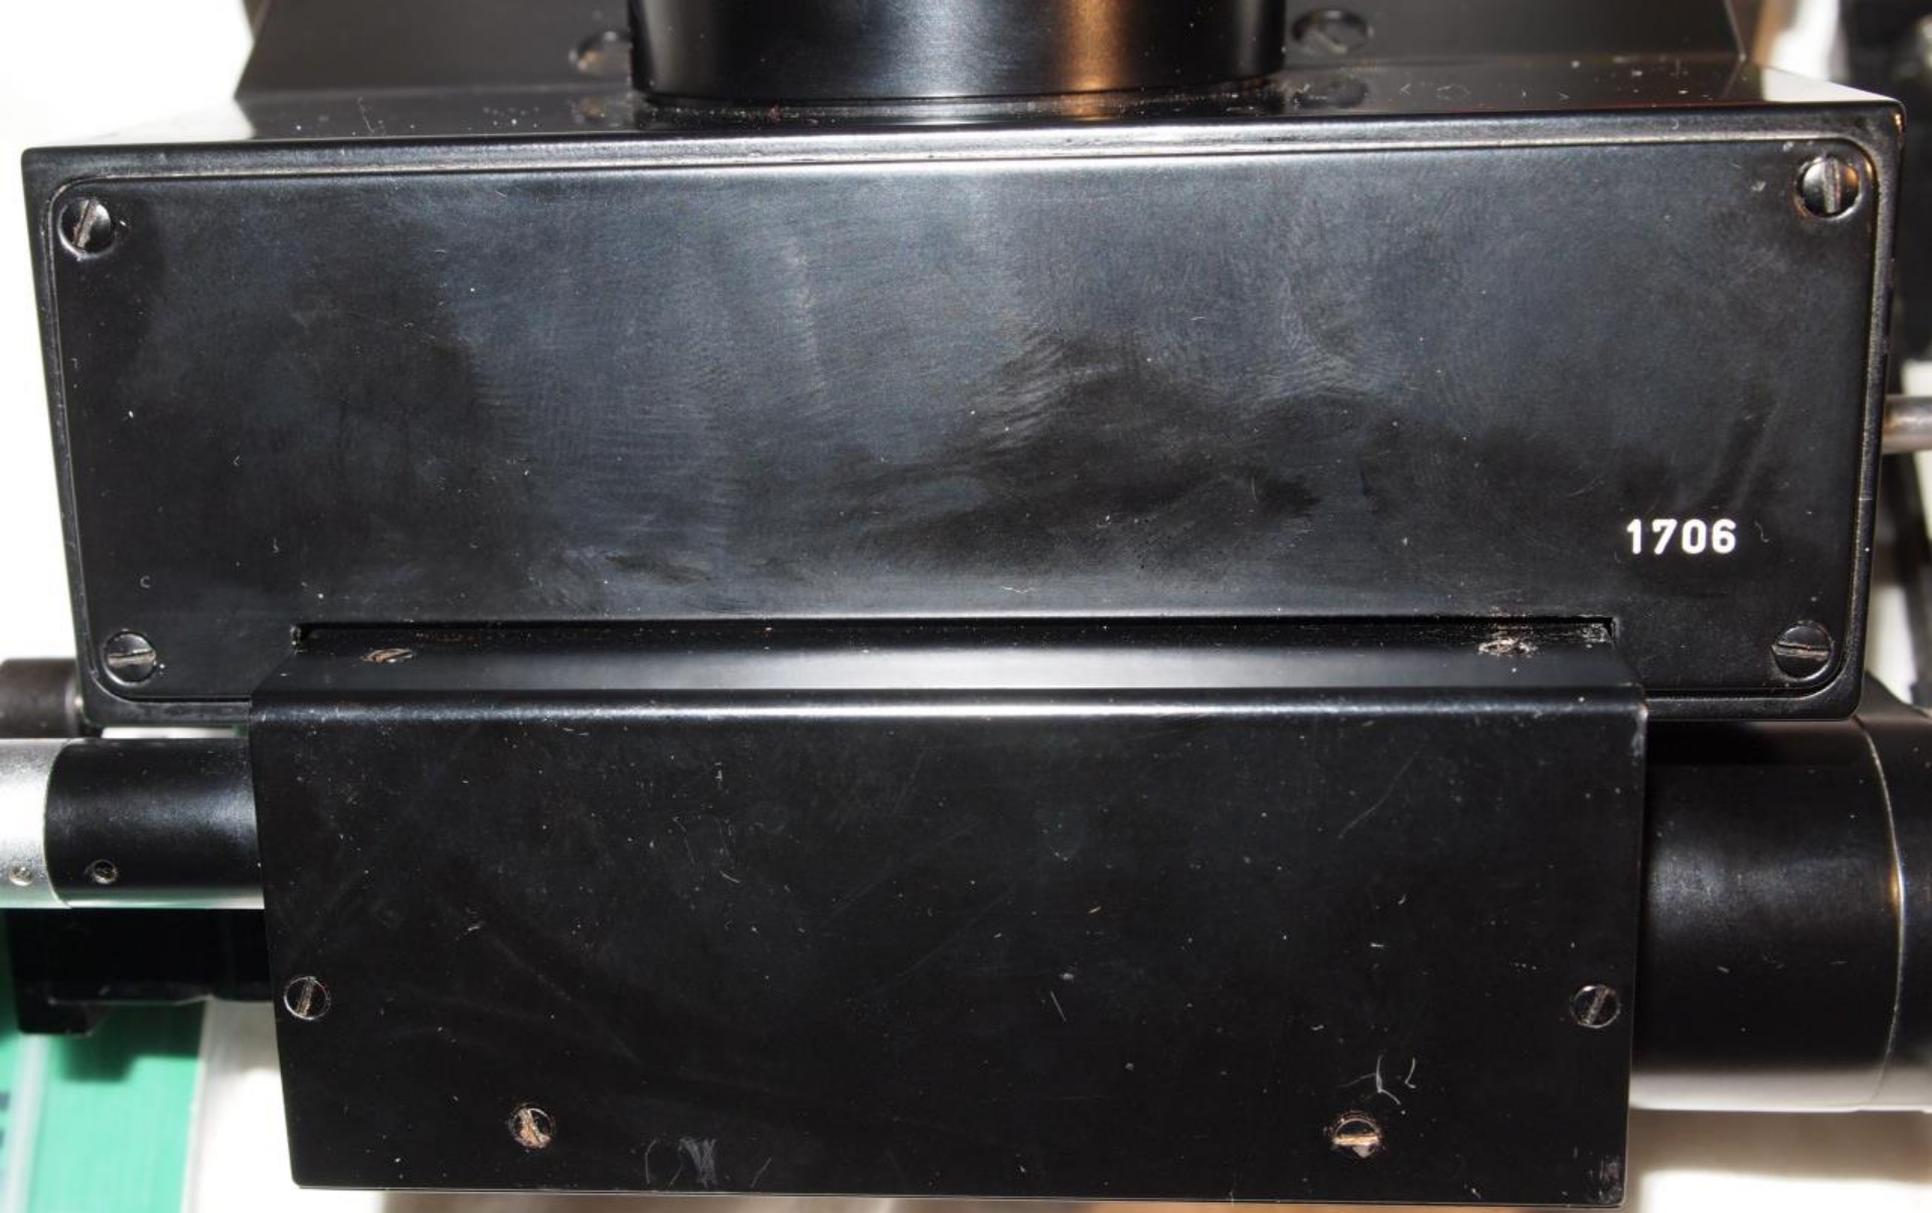
1706

Back of the tube showing upper and lower covers. The lower cover is held on by six screws. The upper cover is held on by four screws. The lower cover has a lip that fits under the upper cover, so remove the upper cover first.

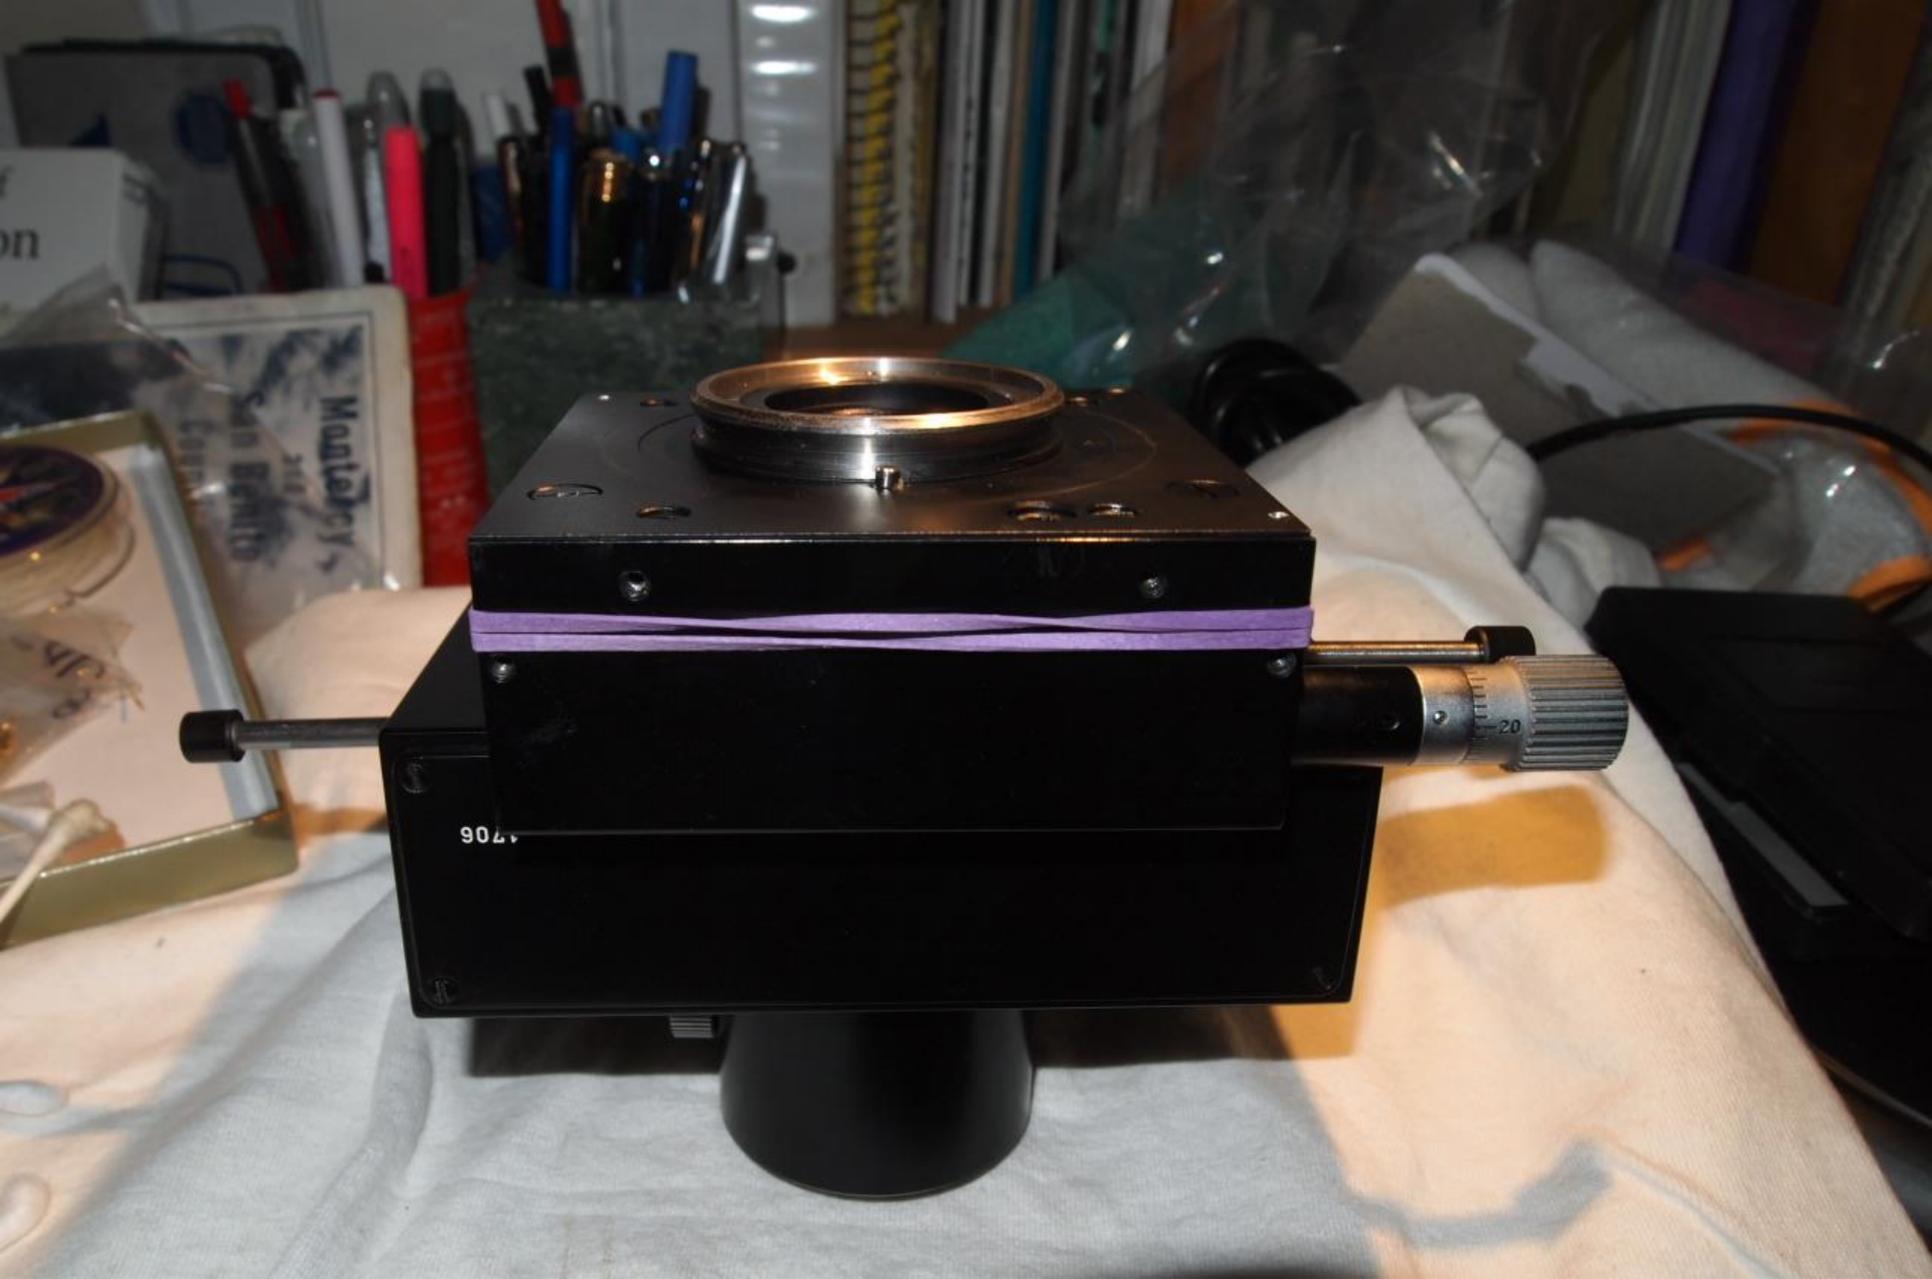
I use rubber bands to hold on the back cover and keep the springs retained. Once secured, my hands are free to deal with the cover screws easily. Don't lose those screws!!

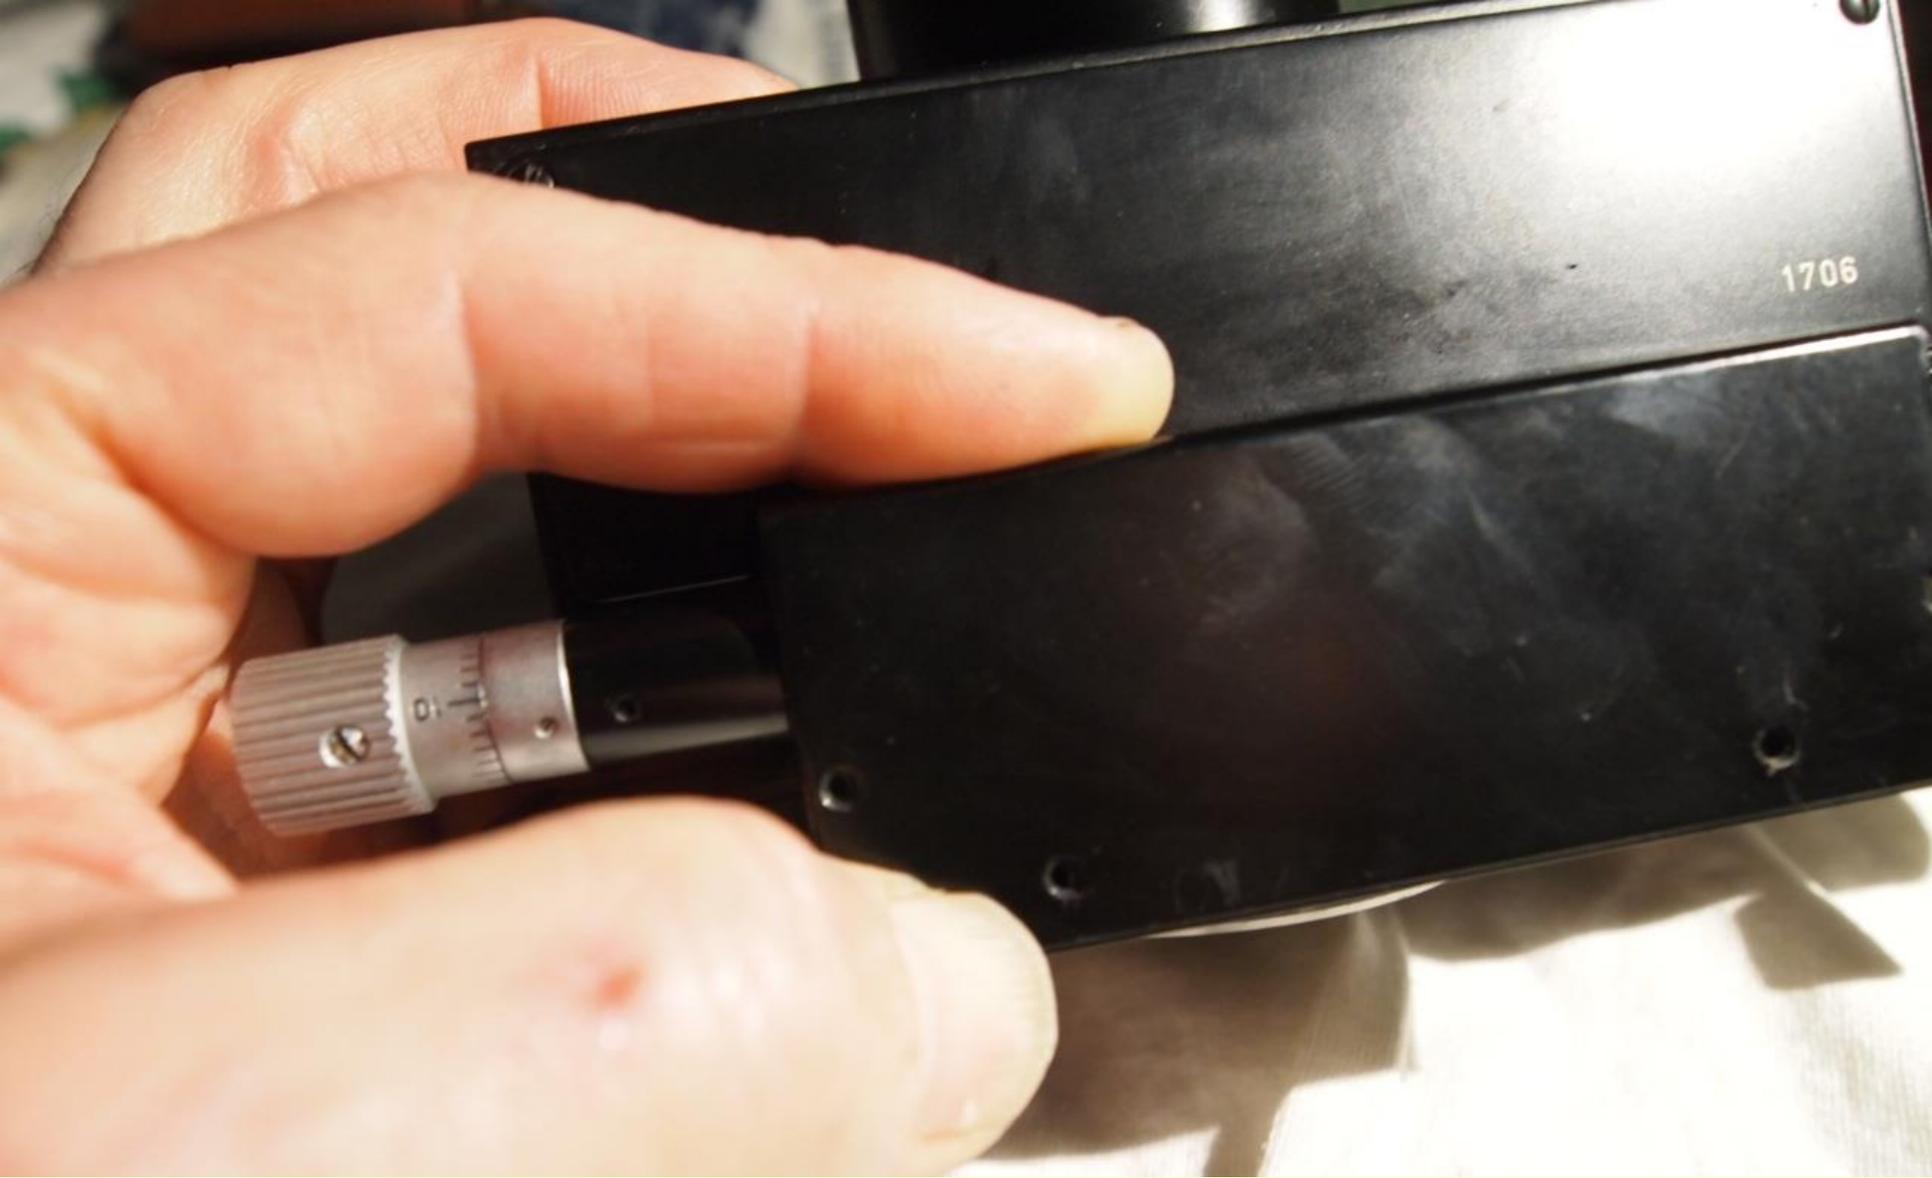
There are three springs resting at a right angle to the back of the lower cover, so hold the cover in place while removing the screws. Rubber bands can be used, so you have both hands free to work.

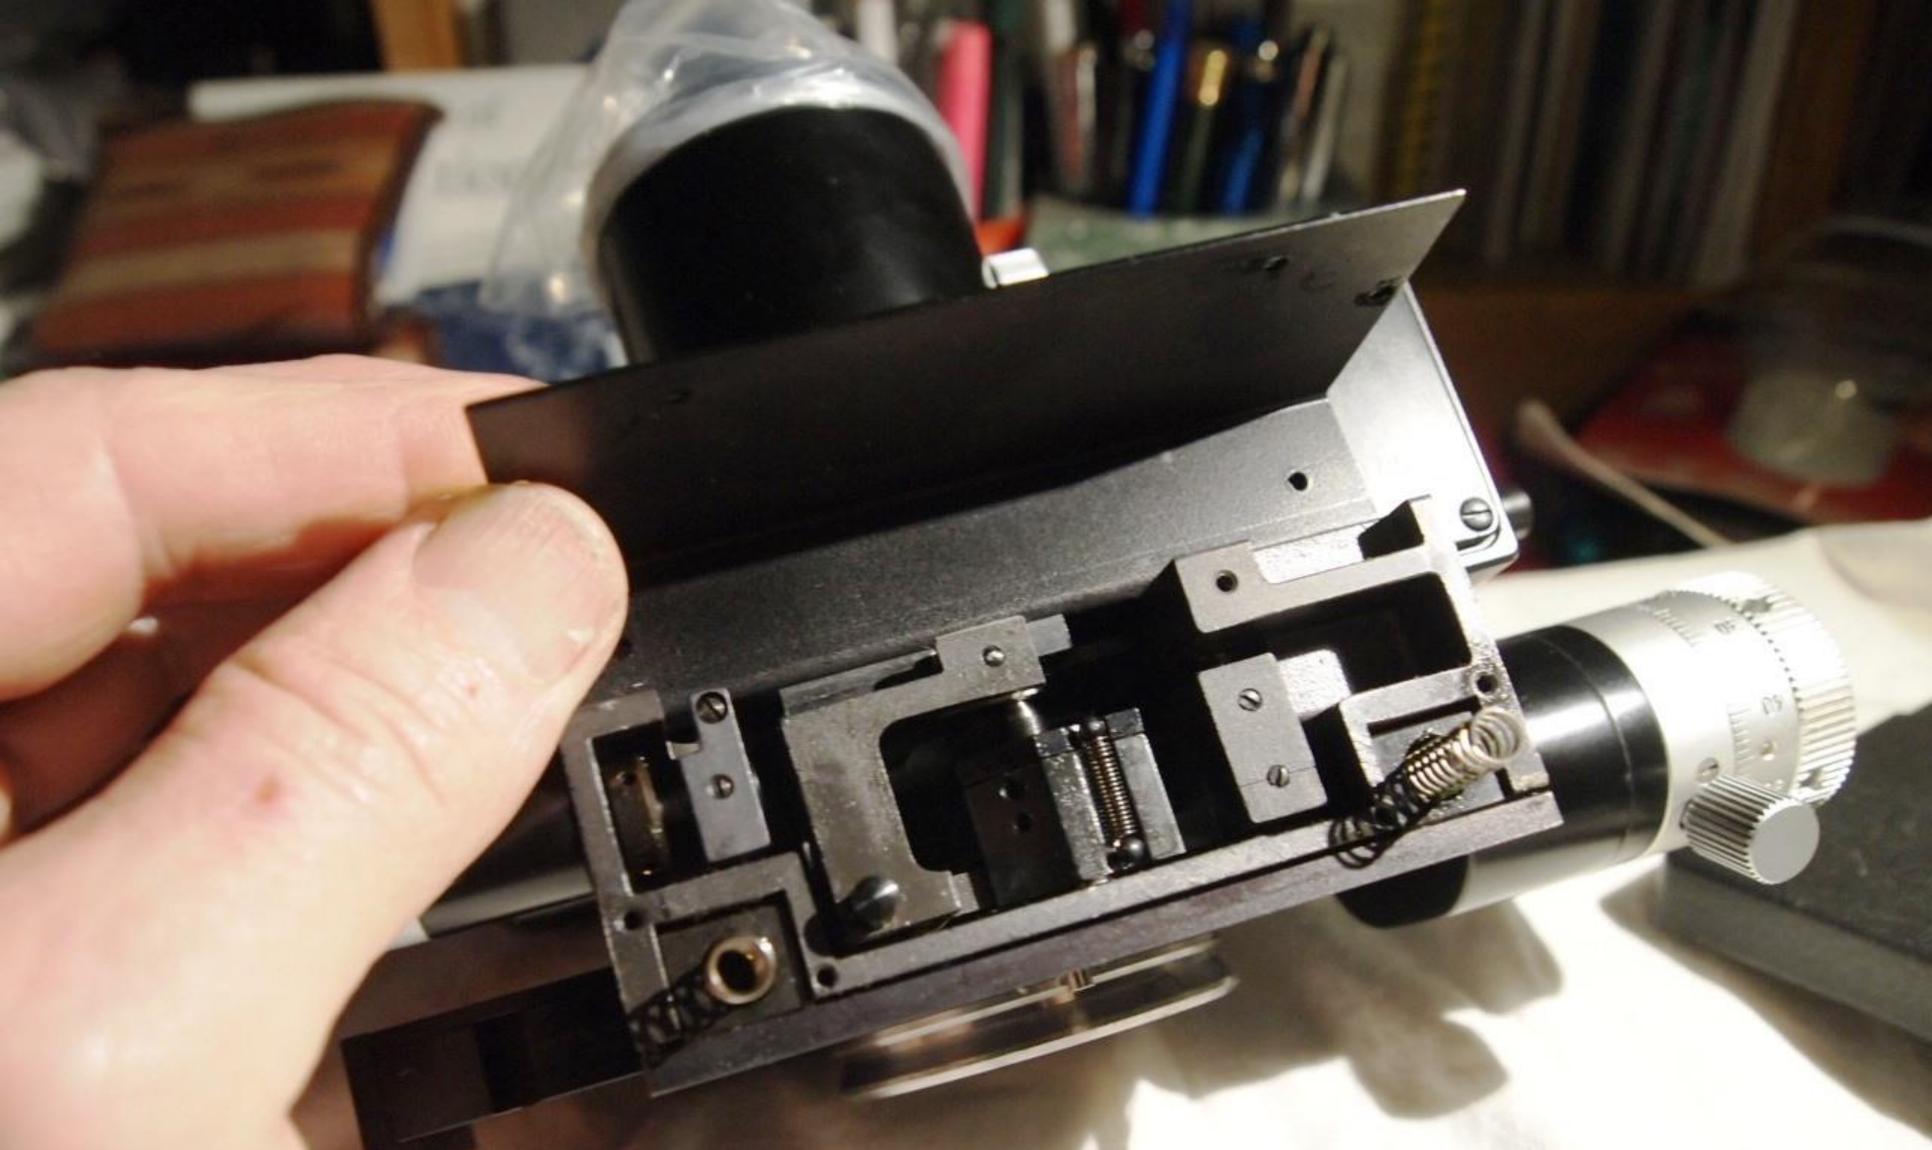
Tip up the cover to remove it, slowly releasing the spring pressure. The outside larger springs put pressure on the analyzer drum slide rollers. The little spring with the black cap is for the swing-out Bertrand lens. The analyzer drum was left in place here, to help orient the reader, but normally take it out (and the eyepieces) before beginning work.

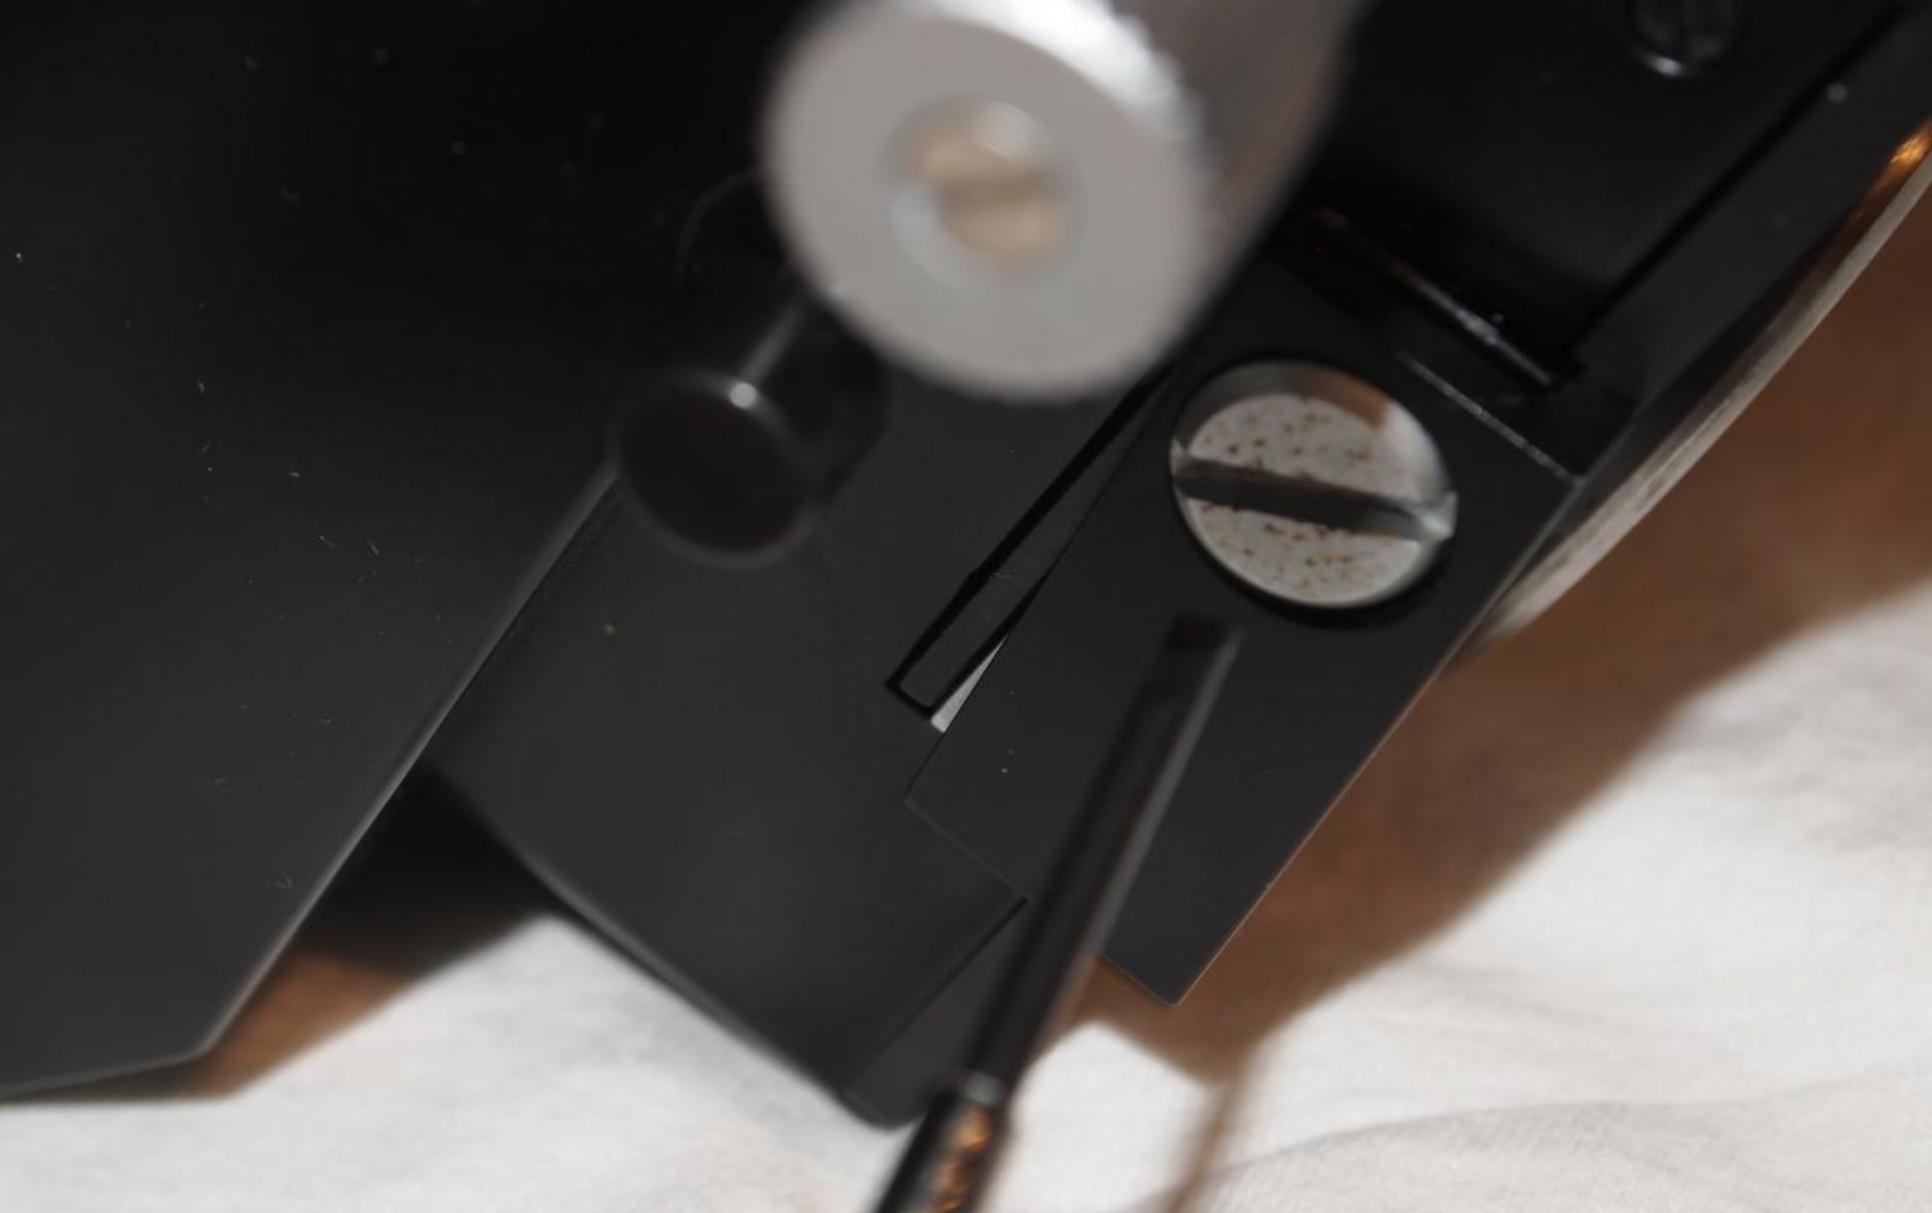
The analyzer retention plate is removed in order to slide out the assembly. This poor little scope has not been in the greatest of environments, as one can see by the corrosion on the retention screw, but it was manufactured in 1982, so we can't be too critical.

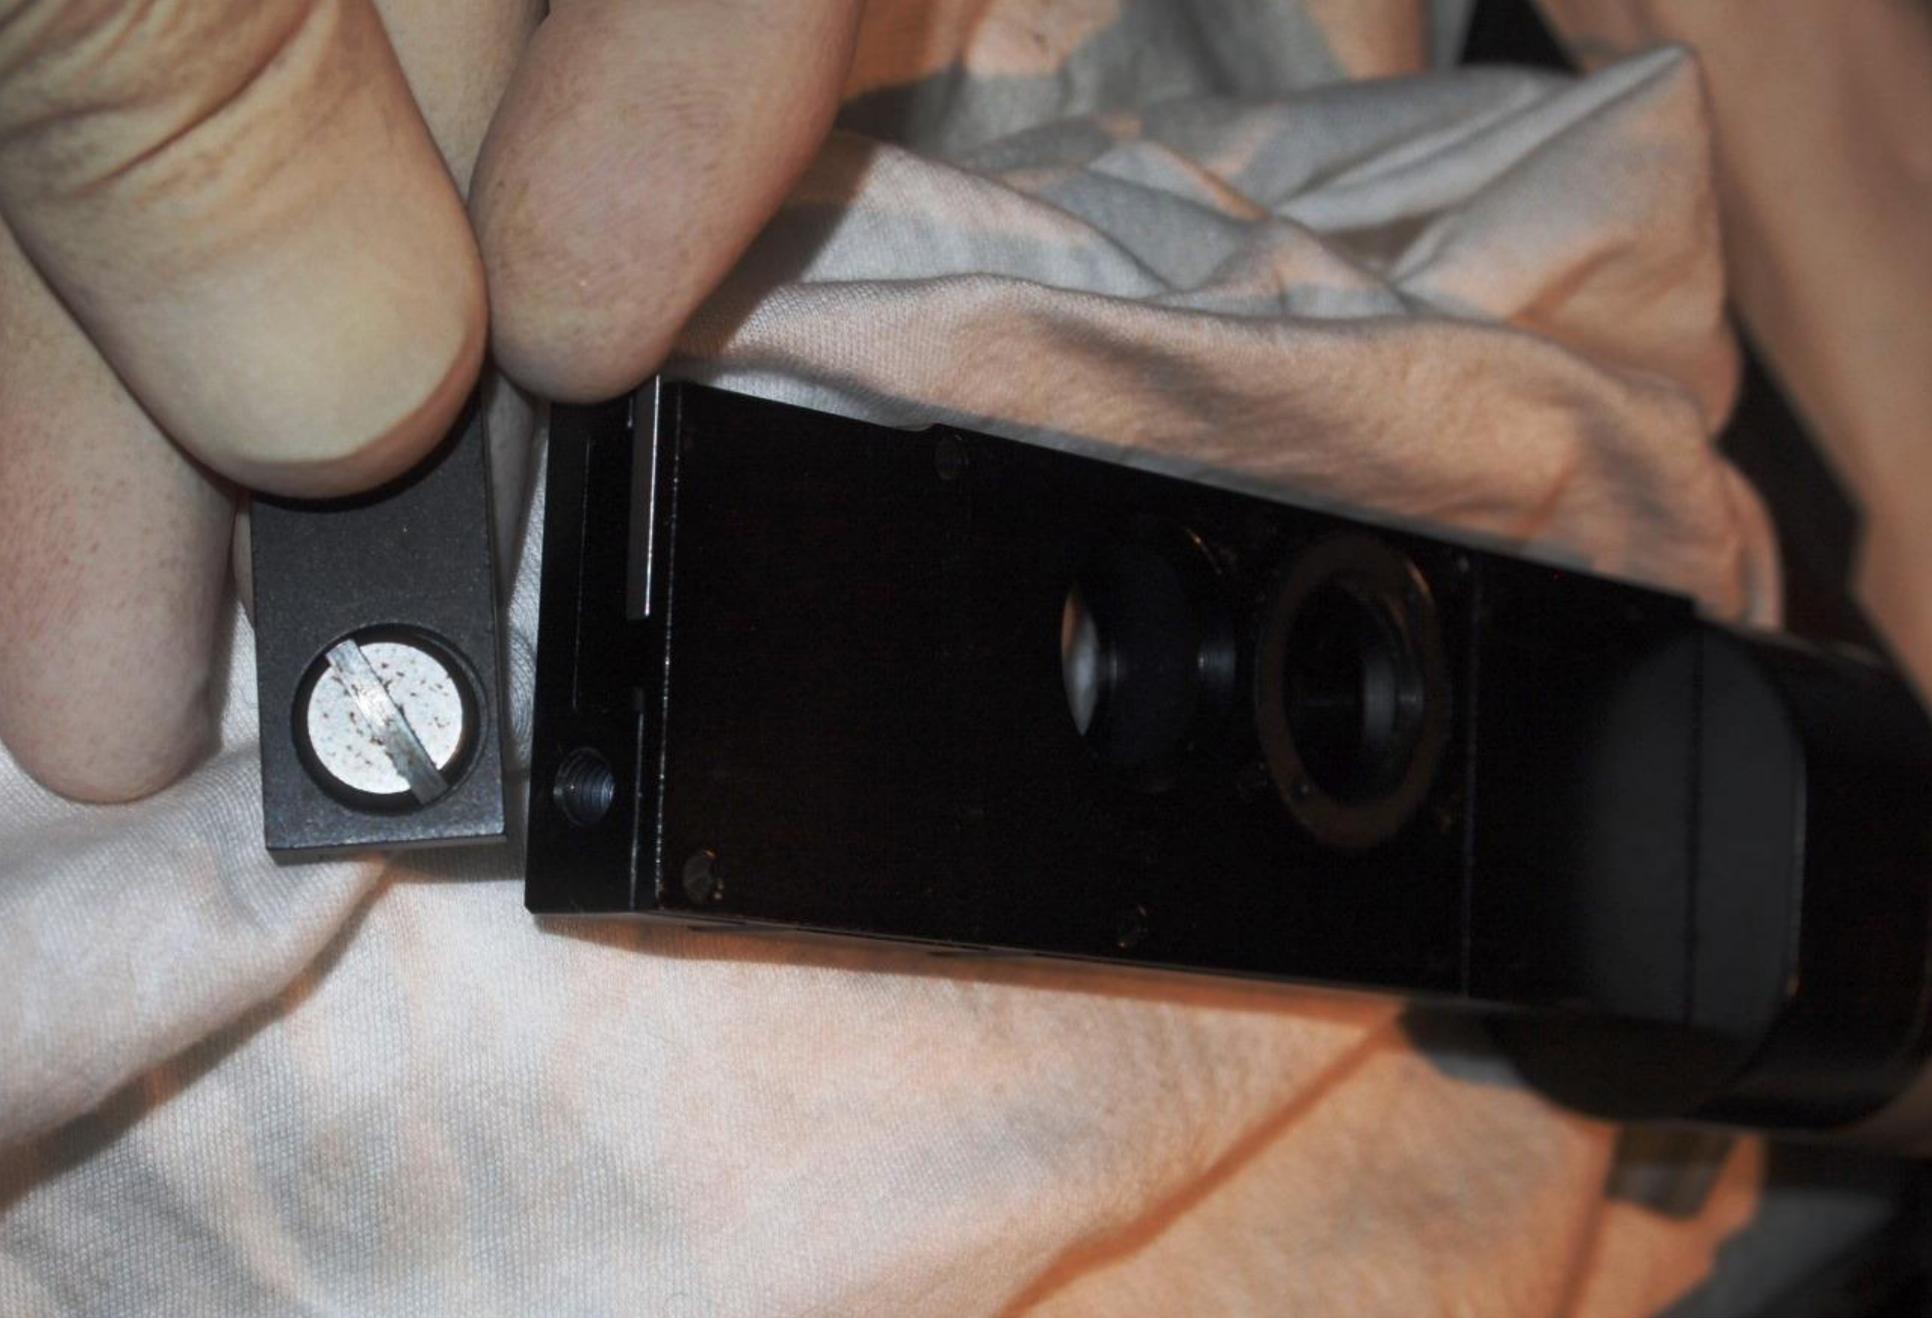
This is a good time to inspect and clean the analyzer.

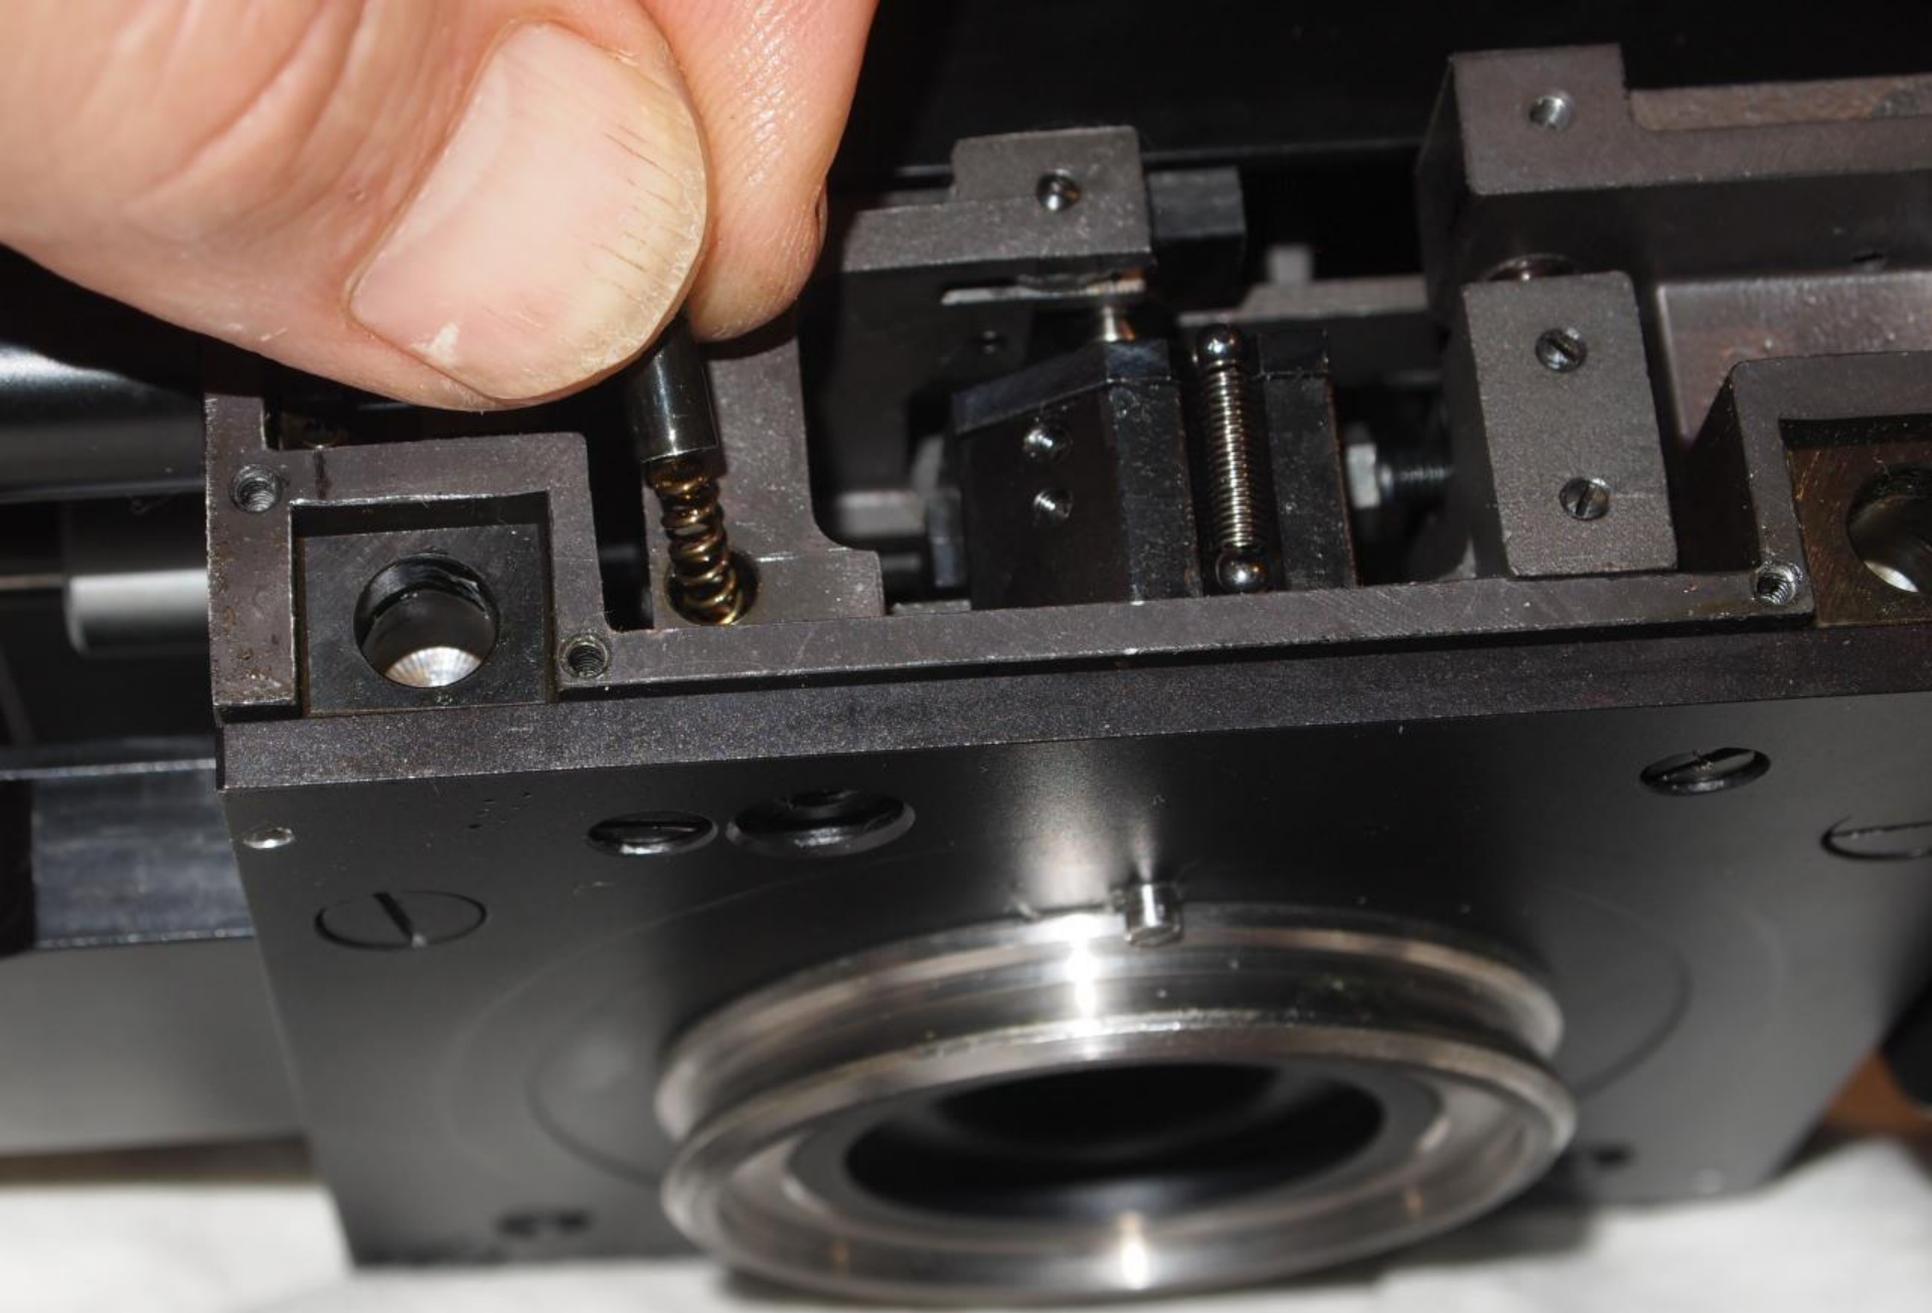
The spring (with cap) for the swing-out Bertrand lens carrier.

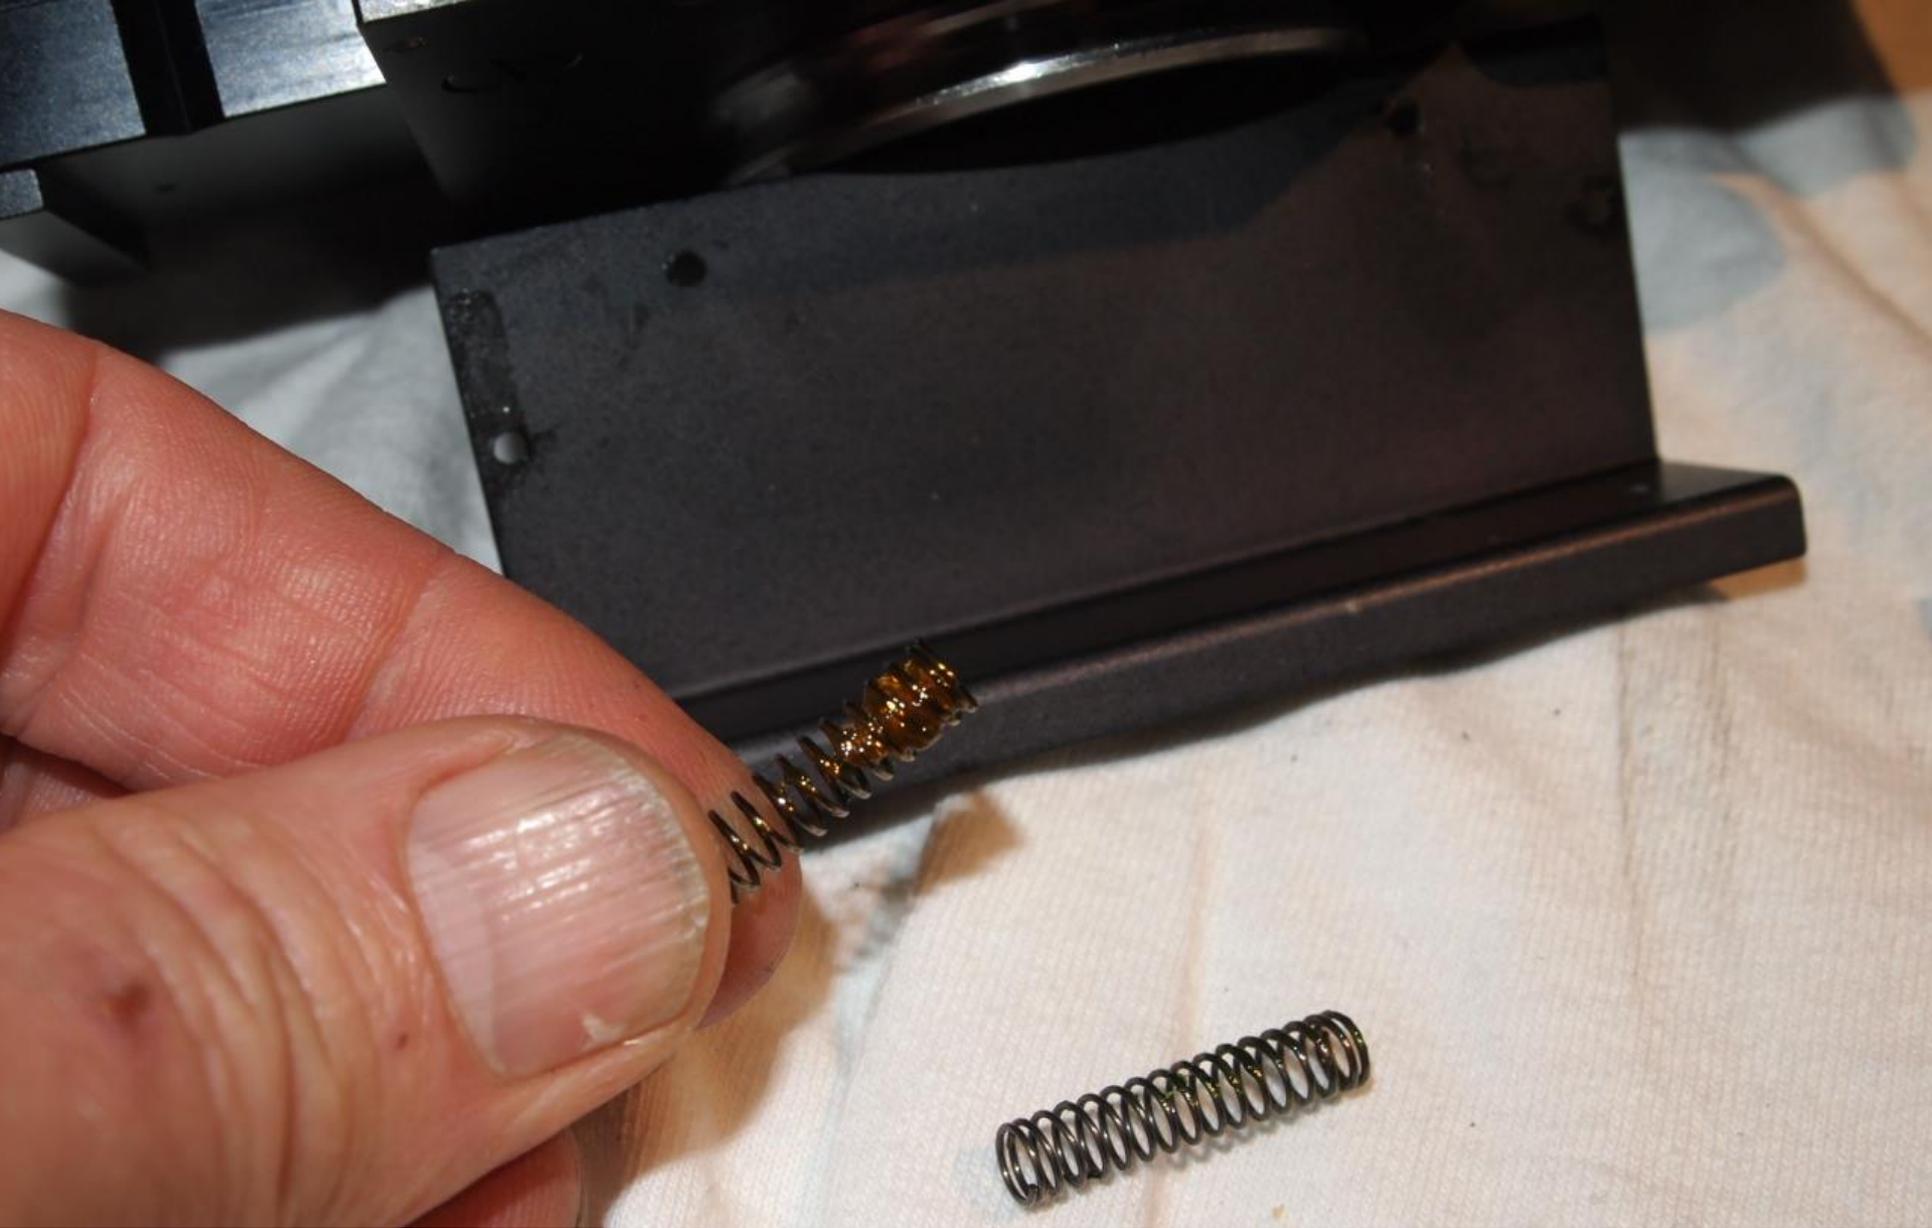
Time to put on nitrile gloves and begin the cleaning process to remove old sticky oil.
