# Repair of the Bertrand Lens Focus Control Wire Leitz Orthoplan FSA-50 Pol-Photo Tube

Michael Cox  
March 01, 2014

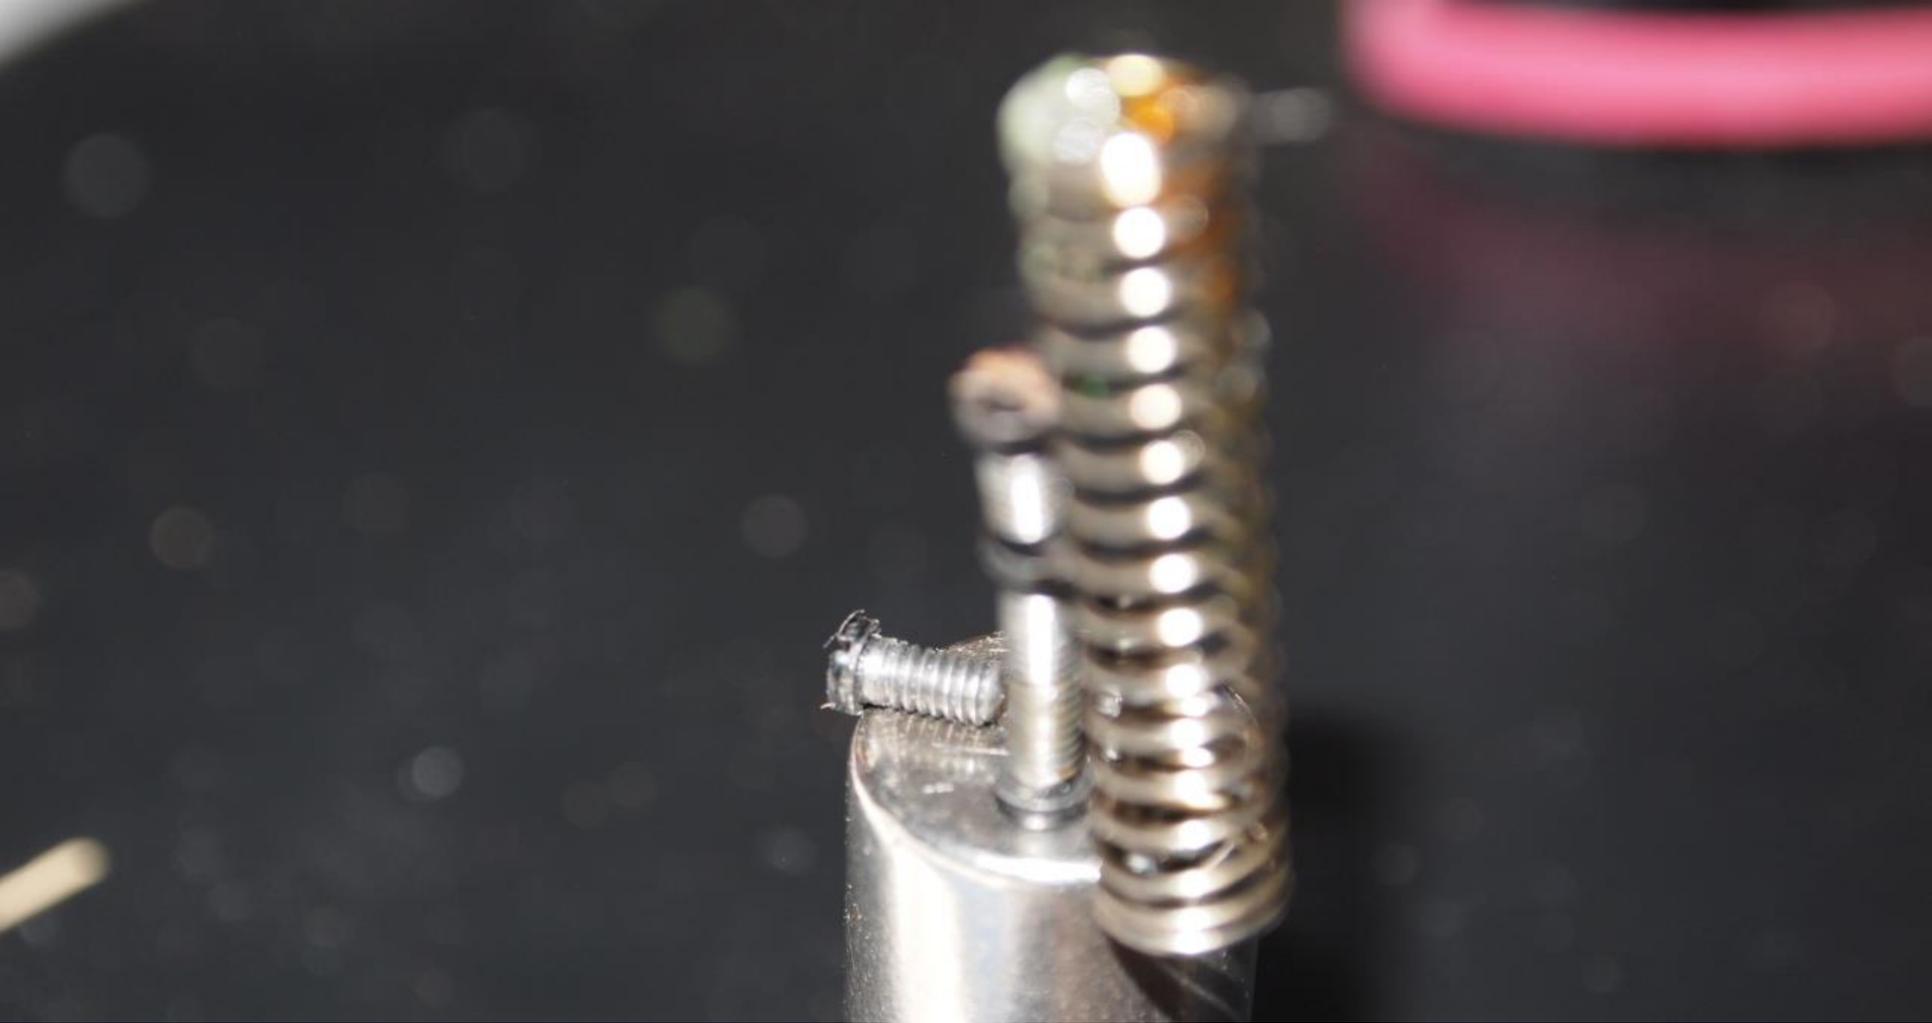
This is what the magnets are for. You do not want to lose any of the little screws or springs. This is also why I work on clean, white, cotton cloth. I use a separate magnet for the screws of each cover, plate, or mechanism I remove. Another option, if repairs are more complicated, is a piece of sticky paper cut into the shape of the object, as if all it's walls and top were folded down, like a cardboard box before it is assembled. Each removed part is placed on the sticky pad in the exact position from where it was removed. No more visual confusion about what goes where!

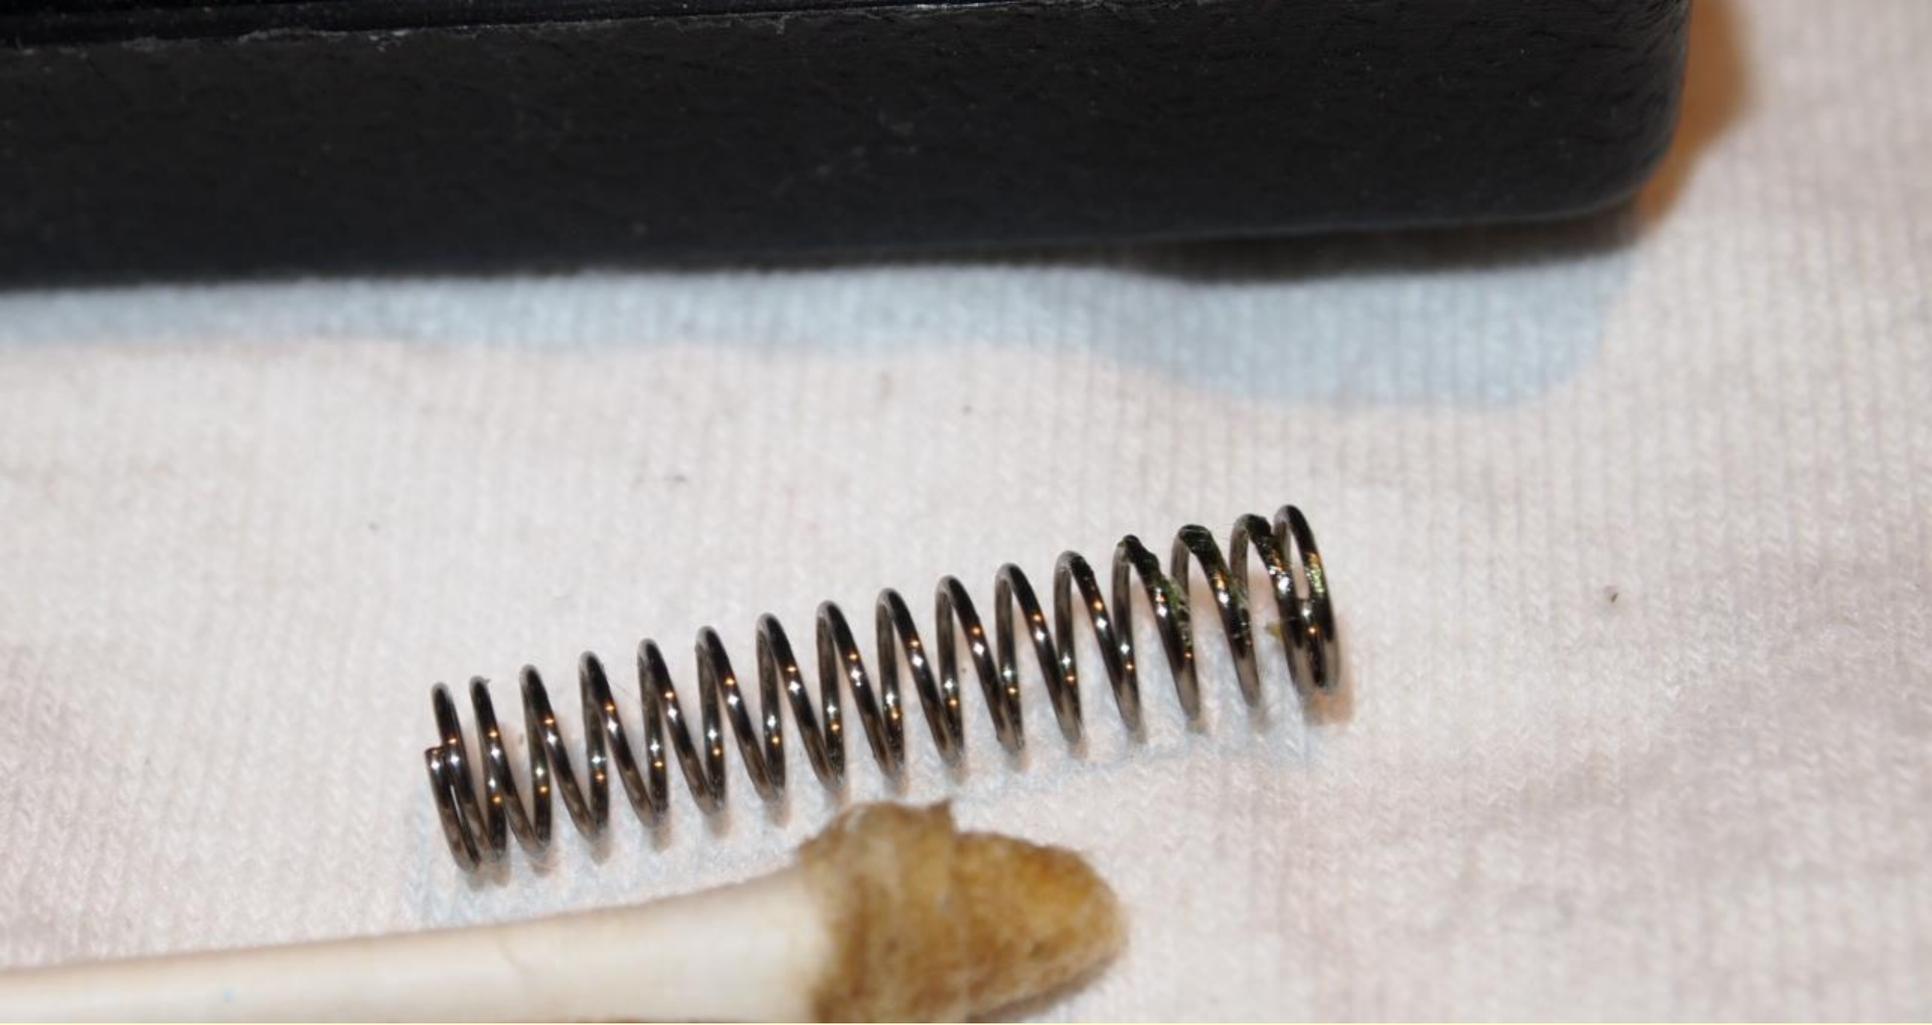
Spring cleaning, very punny! I am using IPA to clean, but not near any of the coated optics! Methylated spirits are death to those. Leitz recommends xylene for cleaning. I do use xylene, but in a fume hood, never indoors where I live. As long as you are in the tube, use premium-quality lens cleaner and tissue to remove any oil fogging etc. that might be on the optics. Use gentle pressure and keep changing the tissue. The rule on optics is to clean them as little as possible, so as to preserve the coatings. For non-optical items, repeat, repeat, repeat, until they are clean.

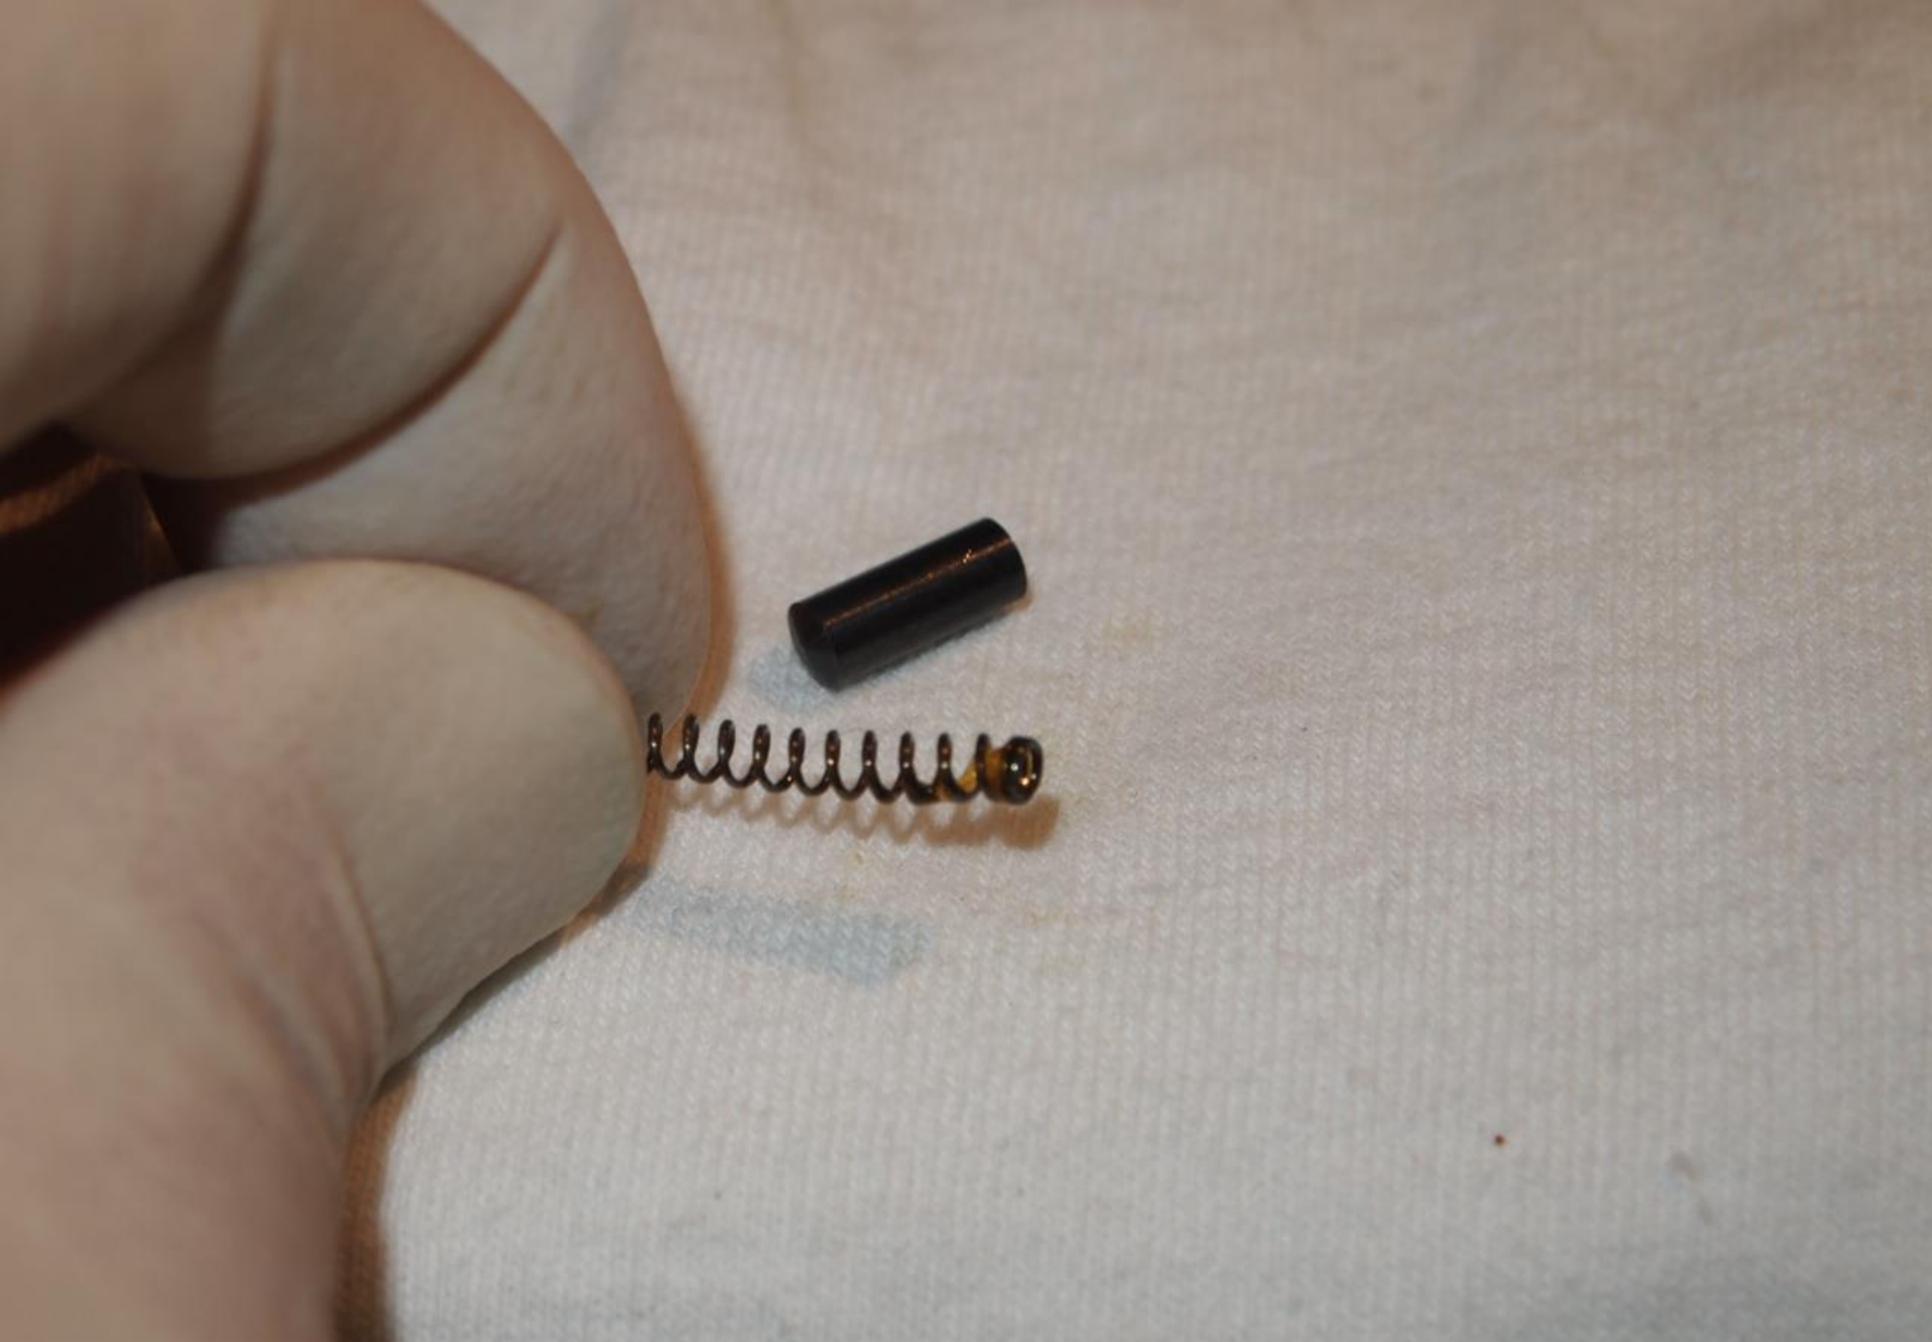
Sticky old oil crud- it's like glue!

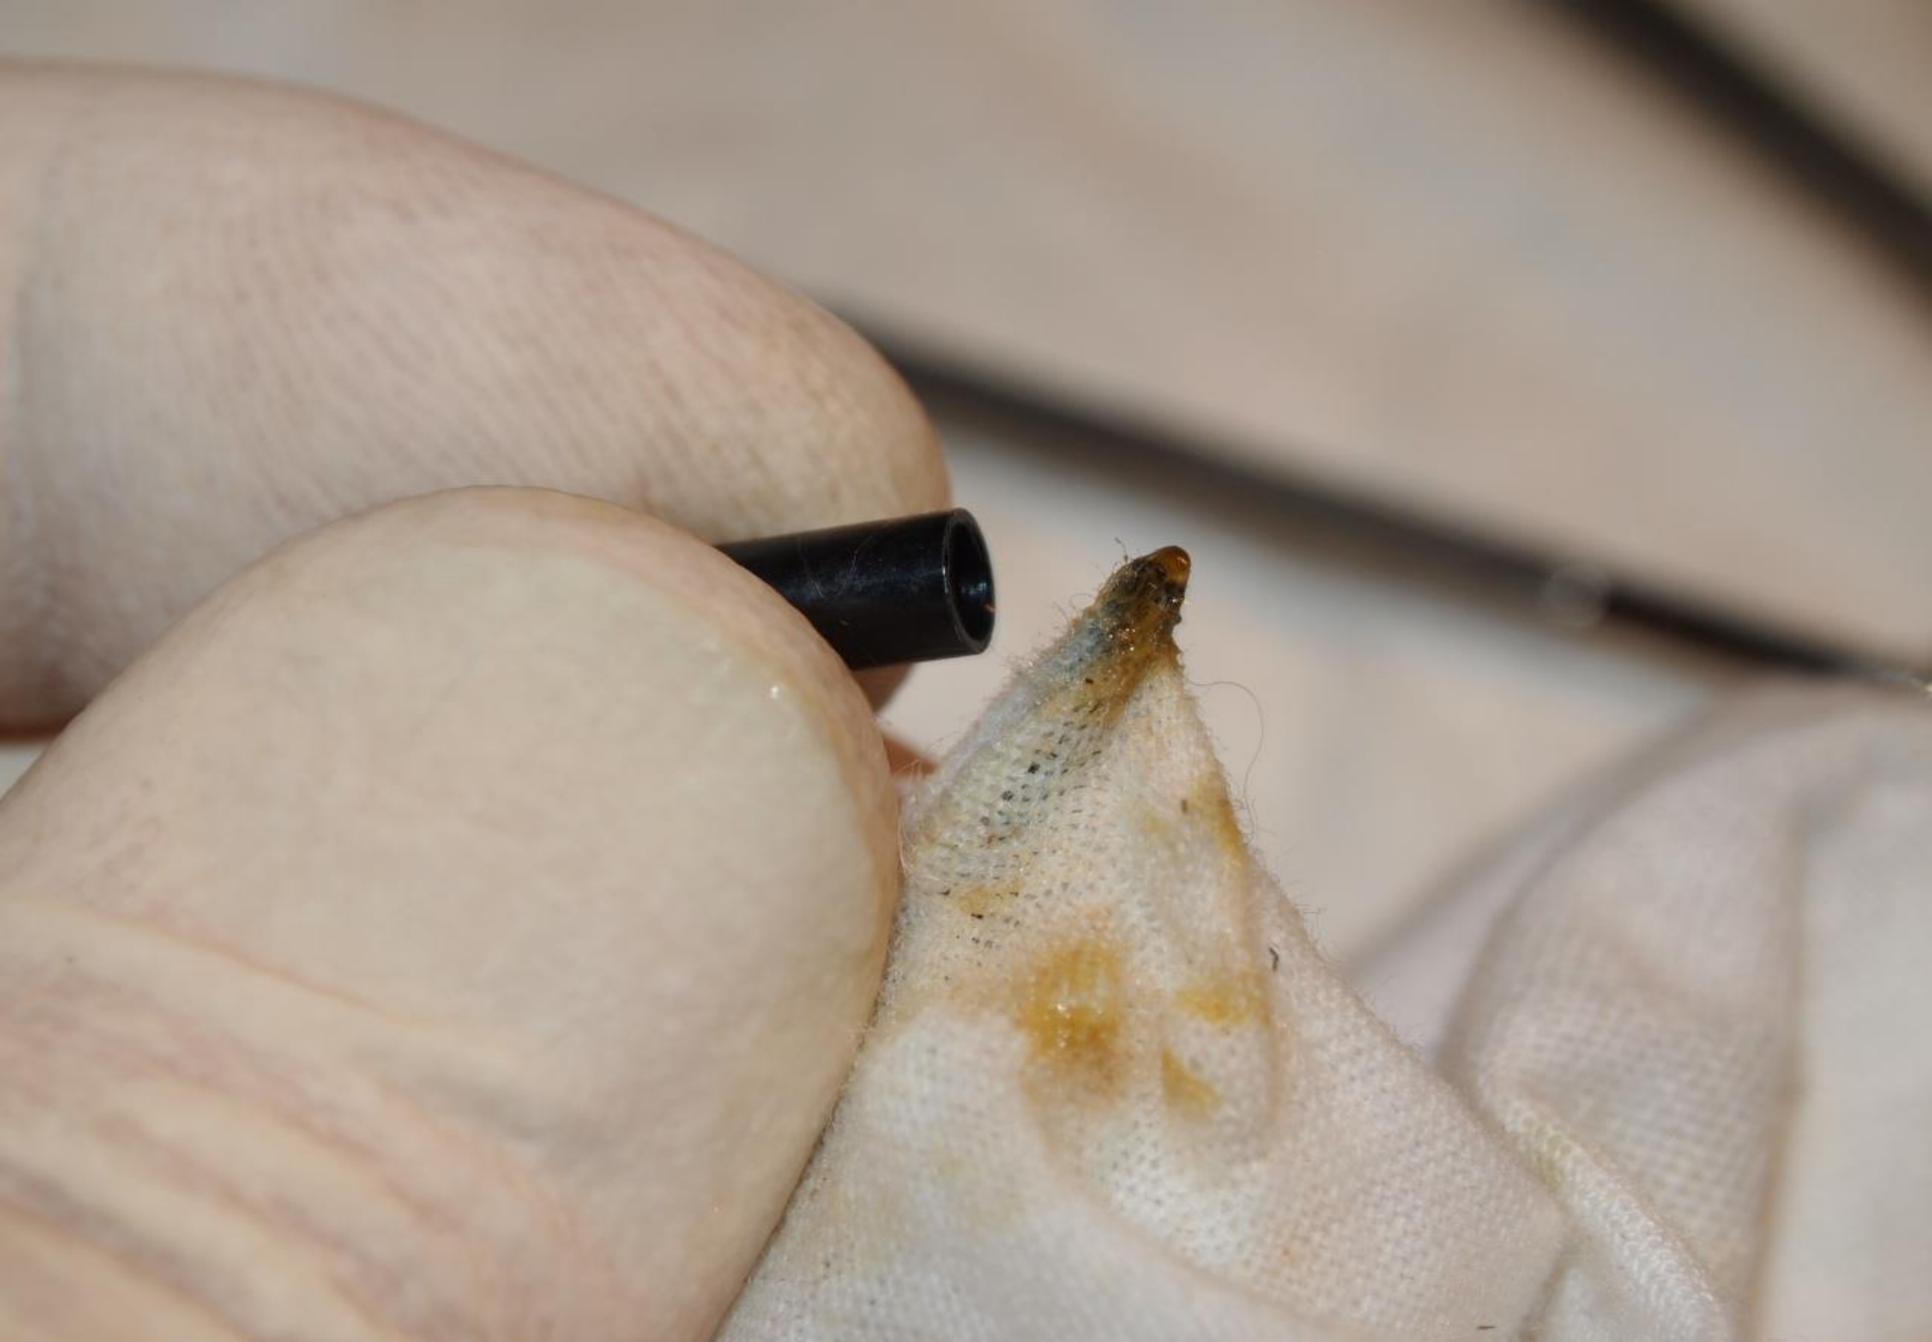
Looks like bearing oil, not microscope grease.

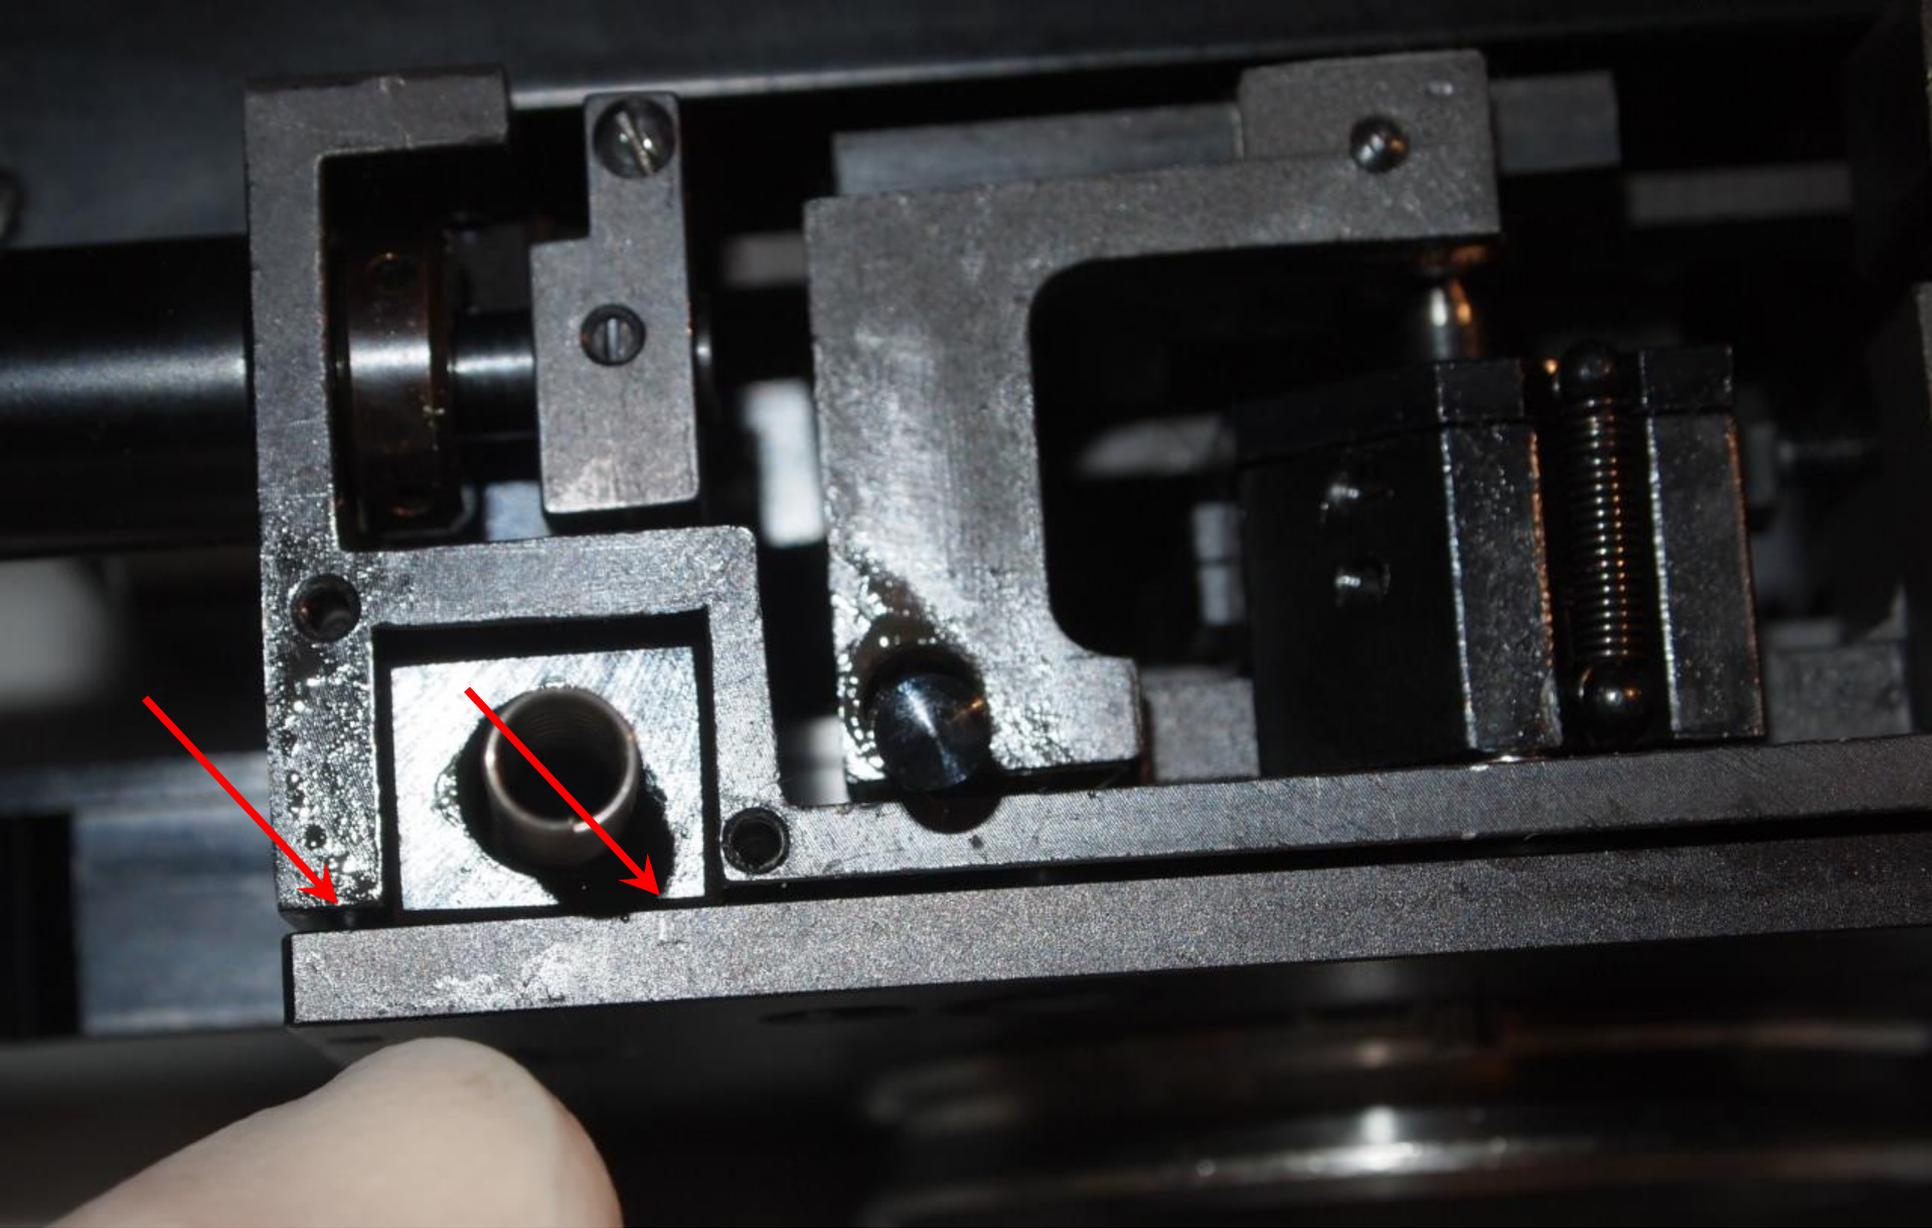
There are some serious fit and alignment problems here. The slider roller blocks are being used to prop up (align) the tube base plate!

The wire has been pulled into the focus block tube and cannot be seen. The crimp is small enough to fit into the tube and large enough not to slip out the smaller hole at the other end. The two screws in the guide roller slots (small arrows, far left and far right) were not tight, and this was the cause of the misalignment seen earlier. In earlier slides you can see the roller blocks sitting at an angle. They were clamped by the base plate as a result, and the analyzer slider was not properly guided by the spring-loaded roller blocks.

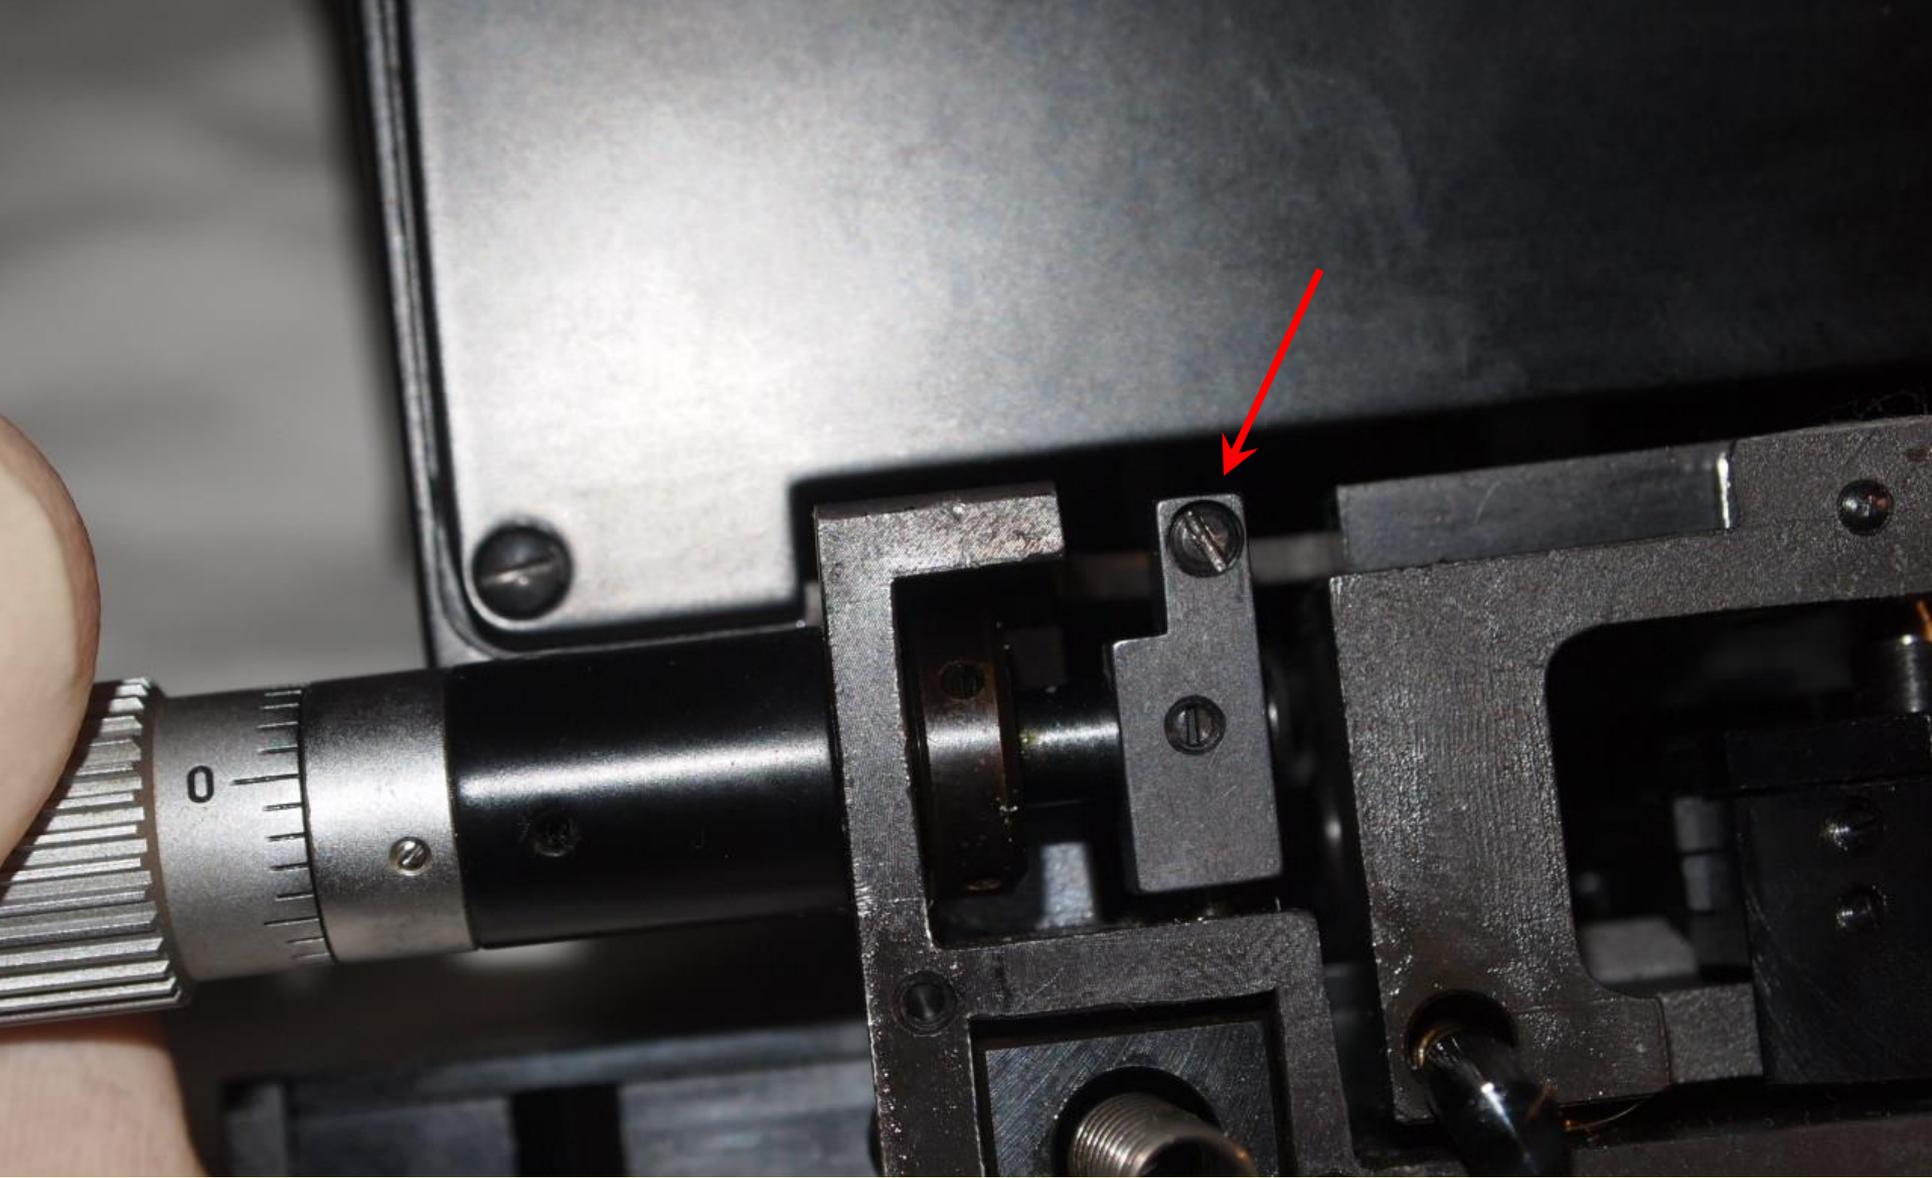
The Bertrand lens focus is not working because the control wire is broken – it's also no where to be found! Someone's been messing around in here. The wire used to be clamped by the top (larger) screw (arrow) on the retention plate.

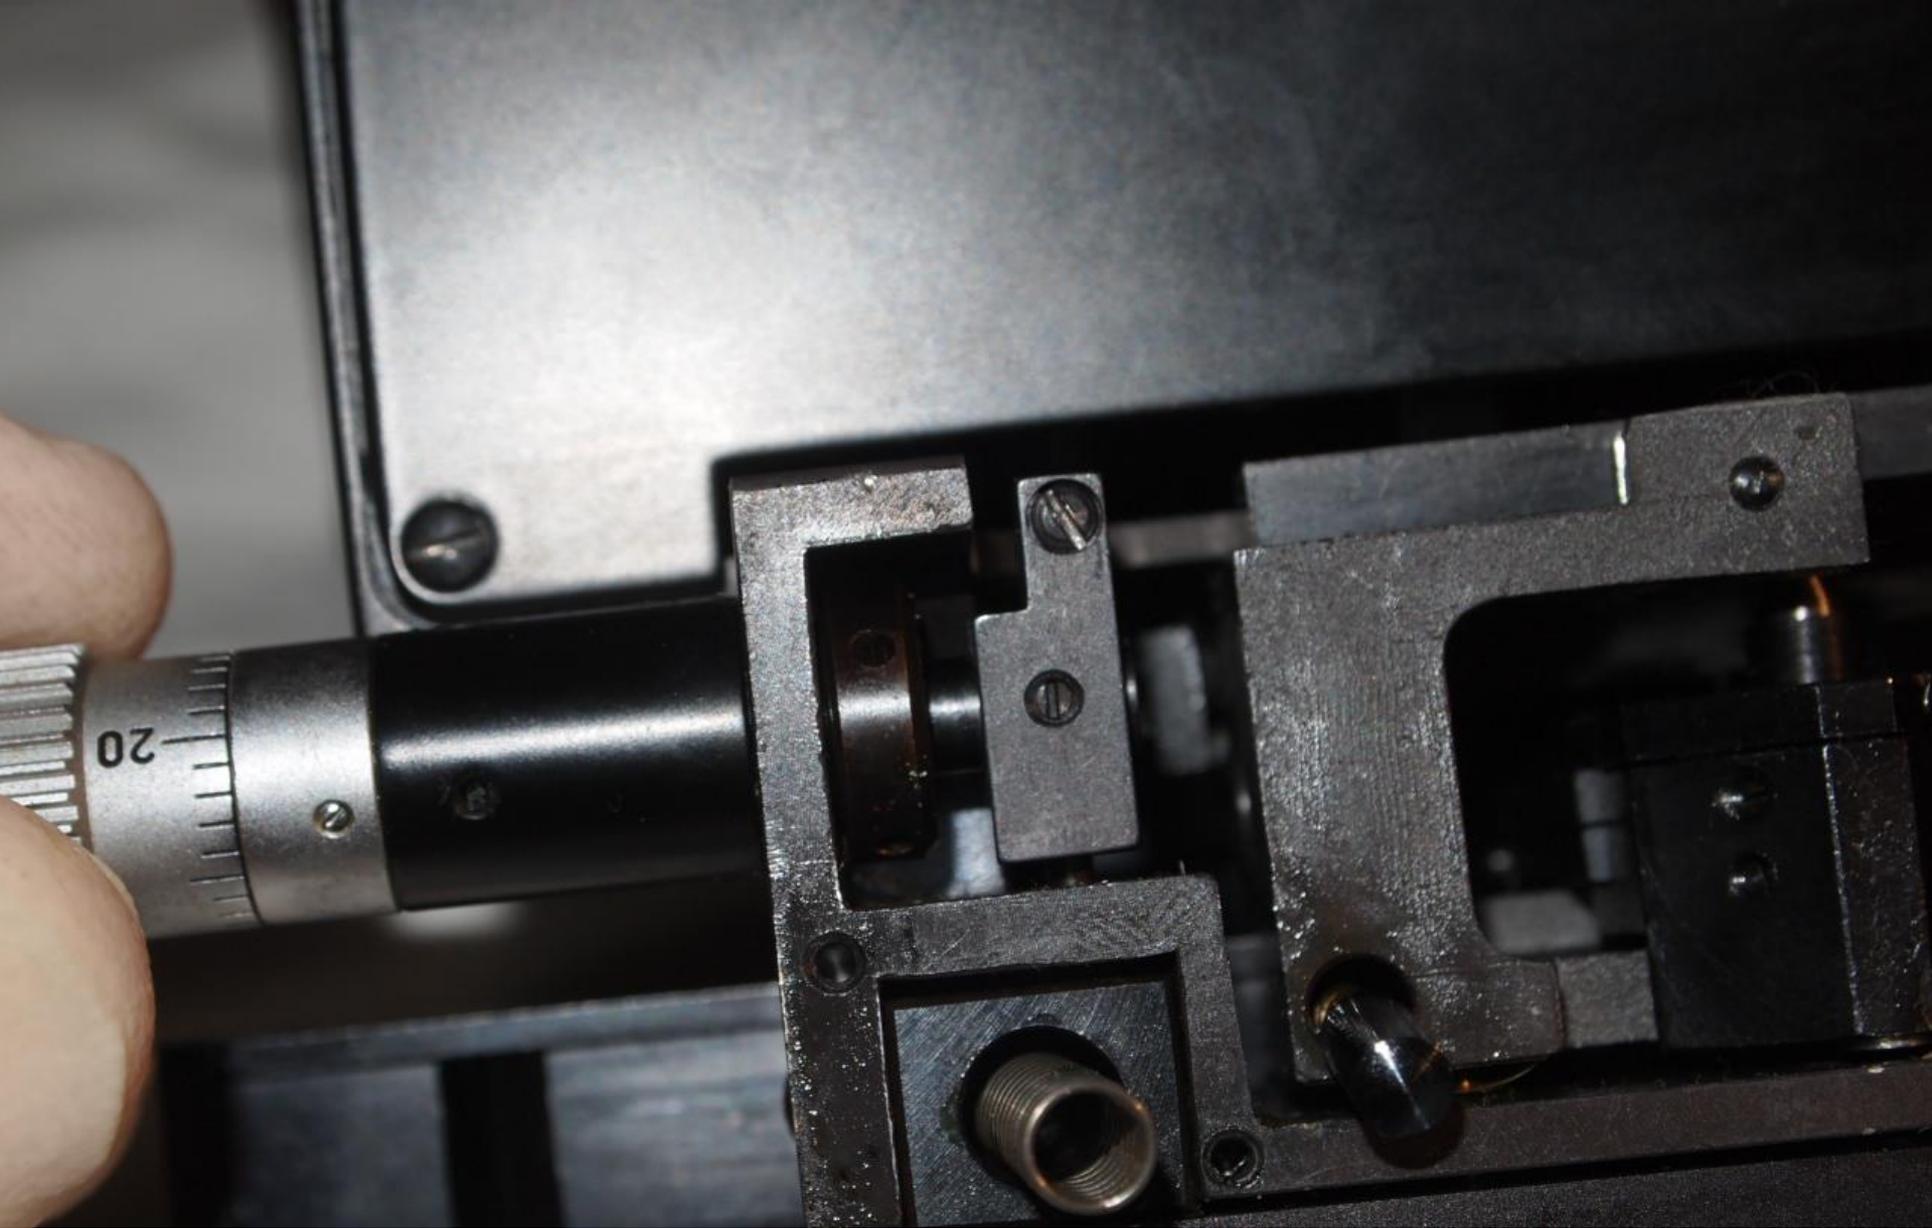
When you turn the adjusting knob, the wire retention plate moves to the left and right. The zero position is all of the way to the right.

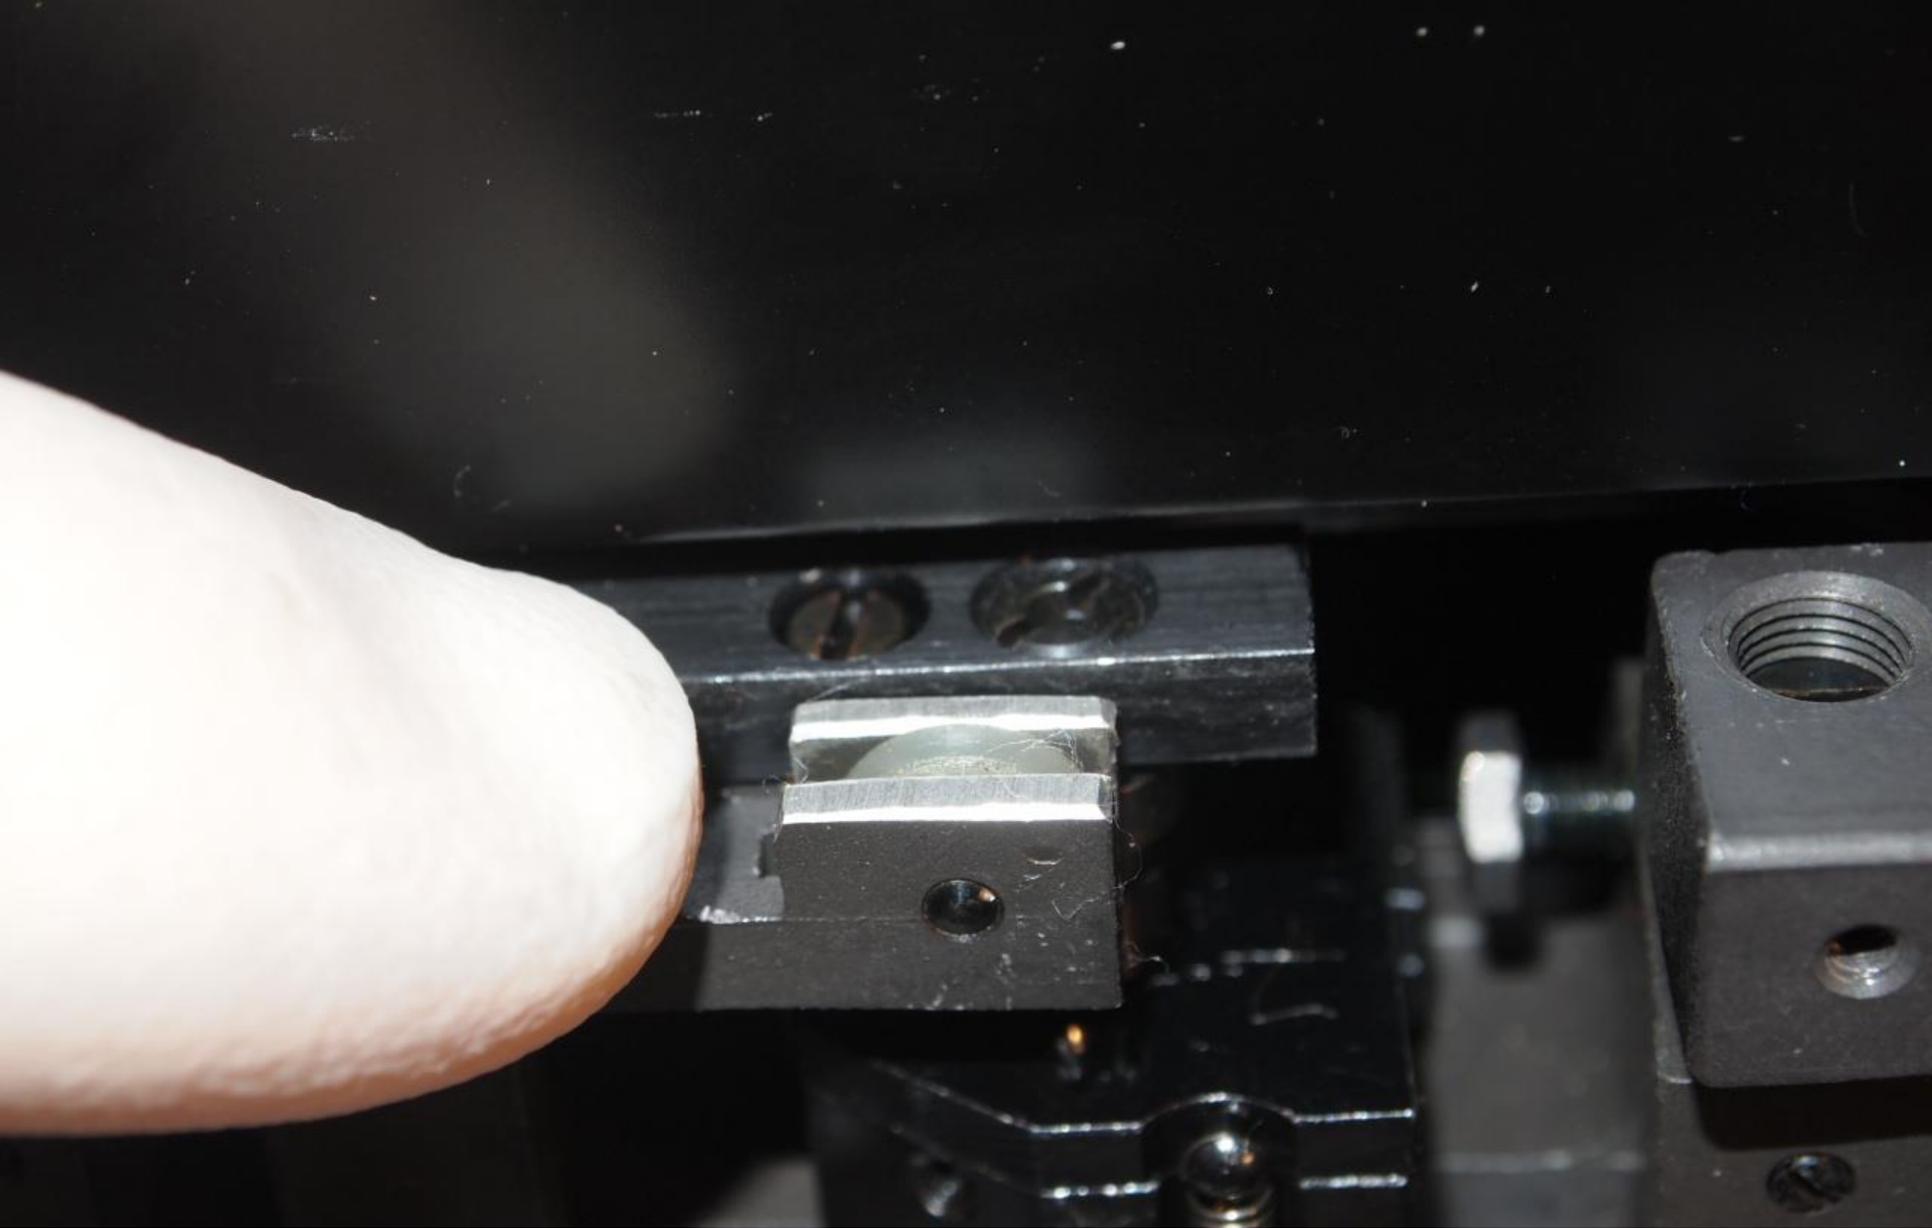
The wire runs over a little pulley and down to the focusing block below.

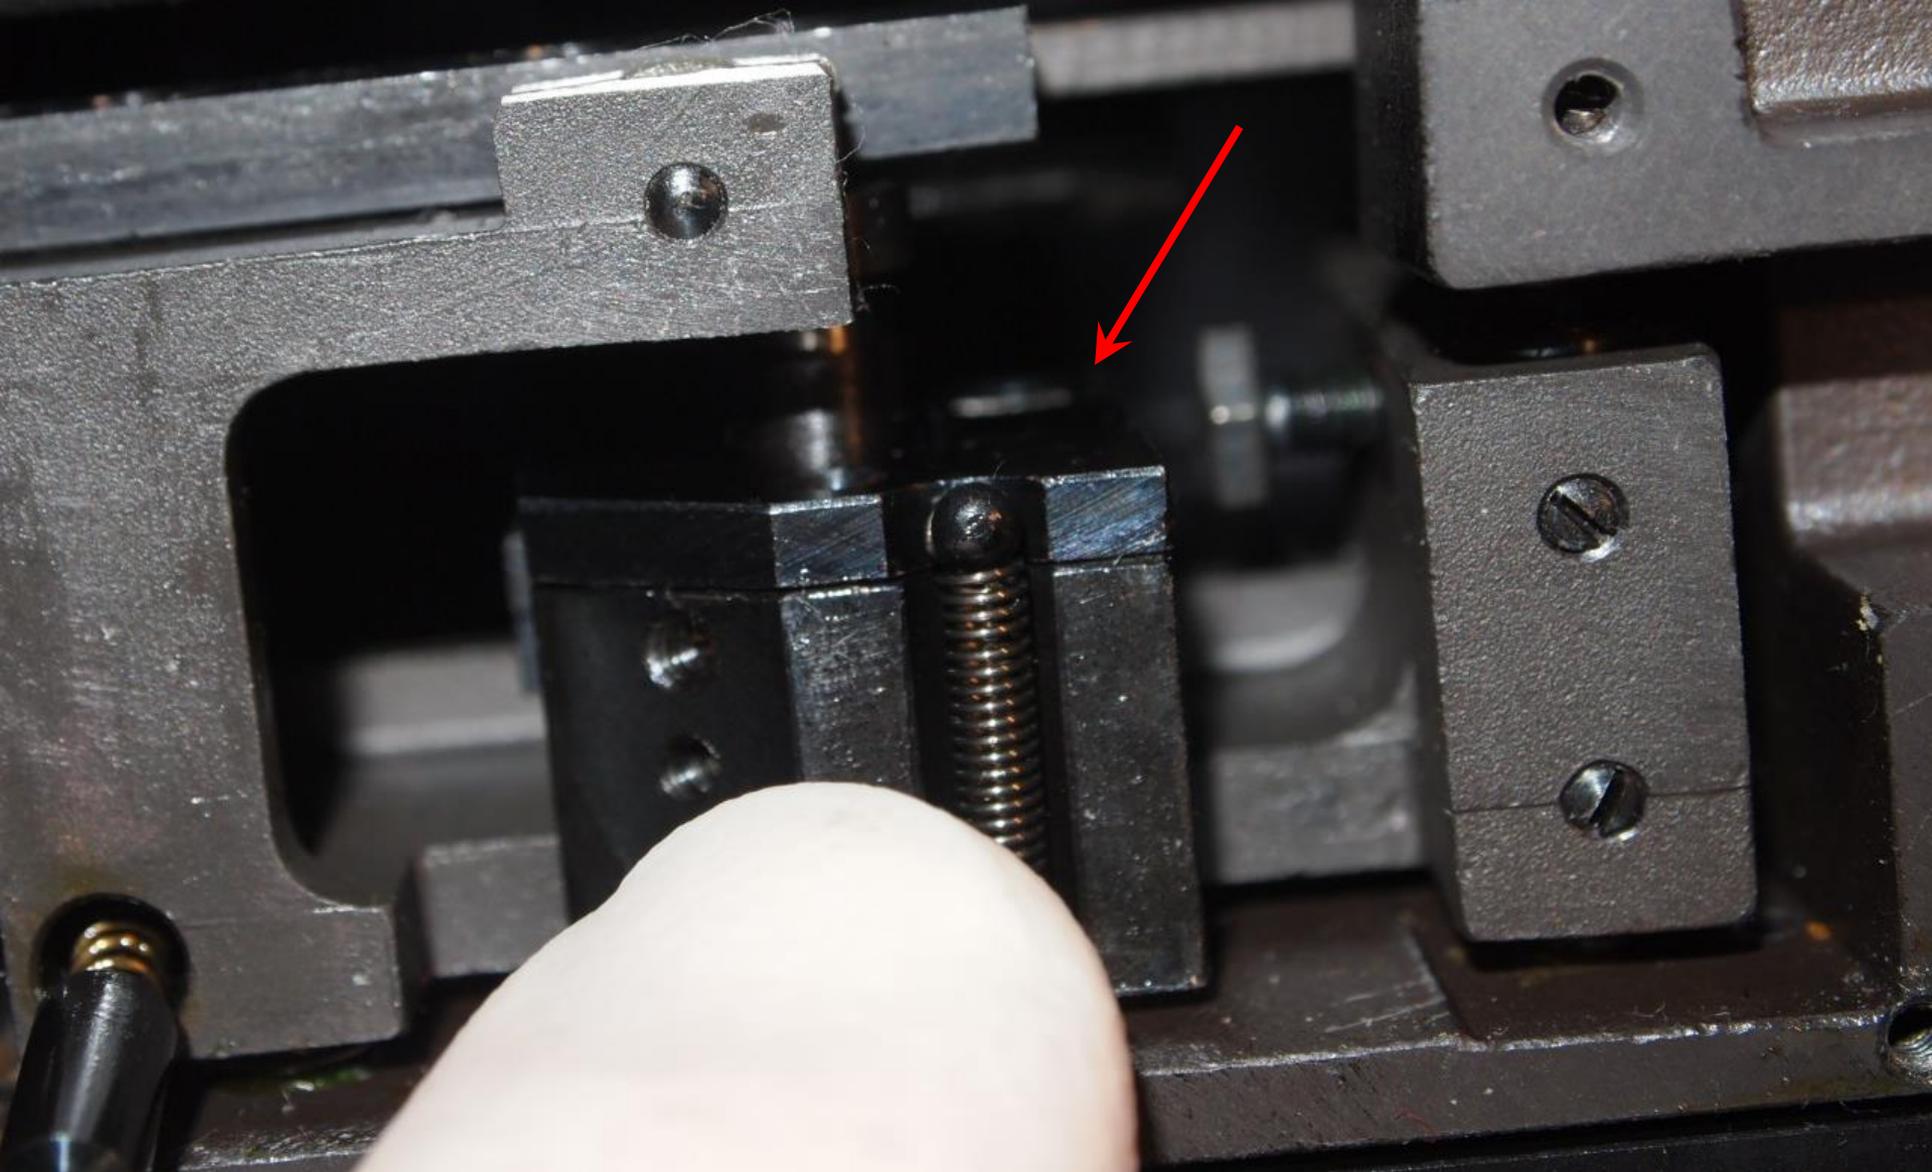
The focusing block moves up and down on a guide rod. Oil gets sticky over time, and someone forced the adjustment knob. It does not take much pressure. This broke the wire. Who needs conoscopic interference analysis anyway!?
