# Repair of the Bertrand Lens Focus Control Wire Leitz Orthoplan FSA-50 Pol-Photo Tube

Michael Cox  
March 01, 2014

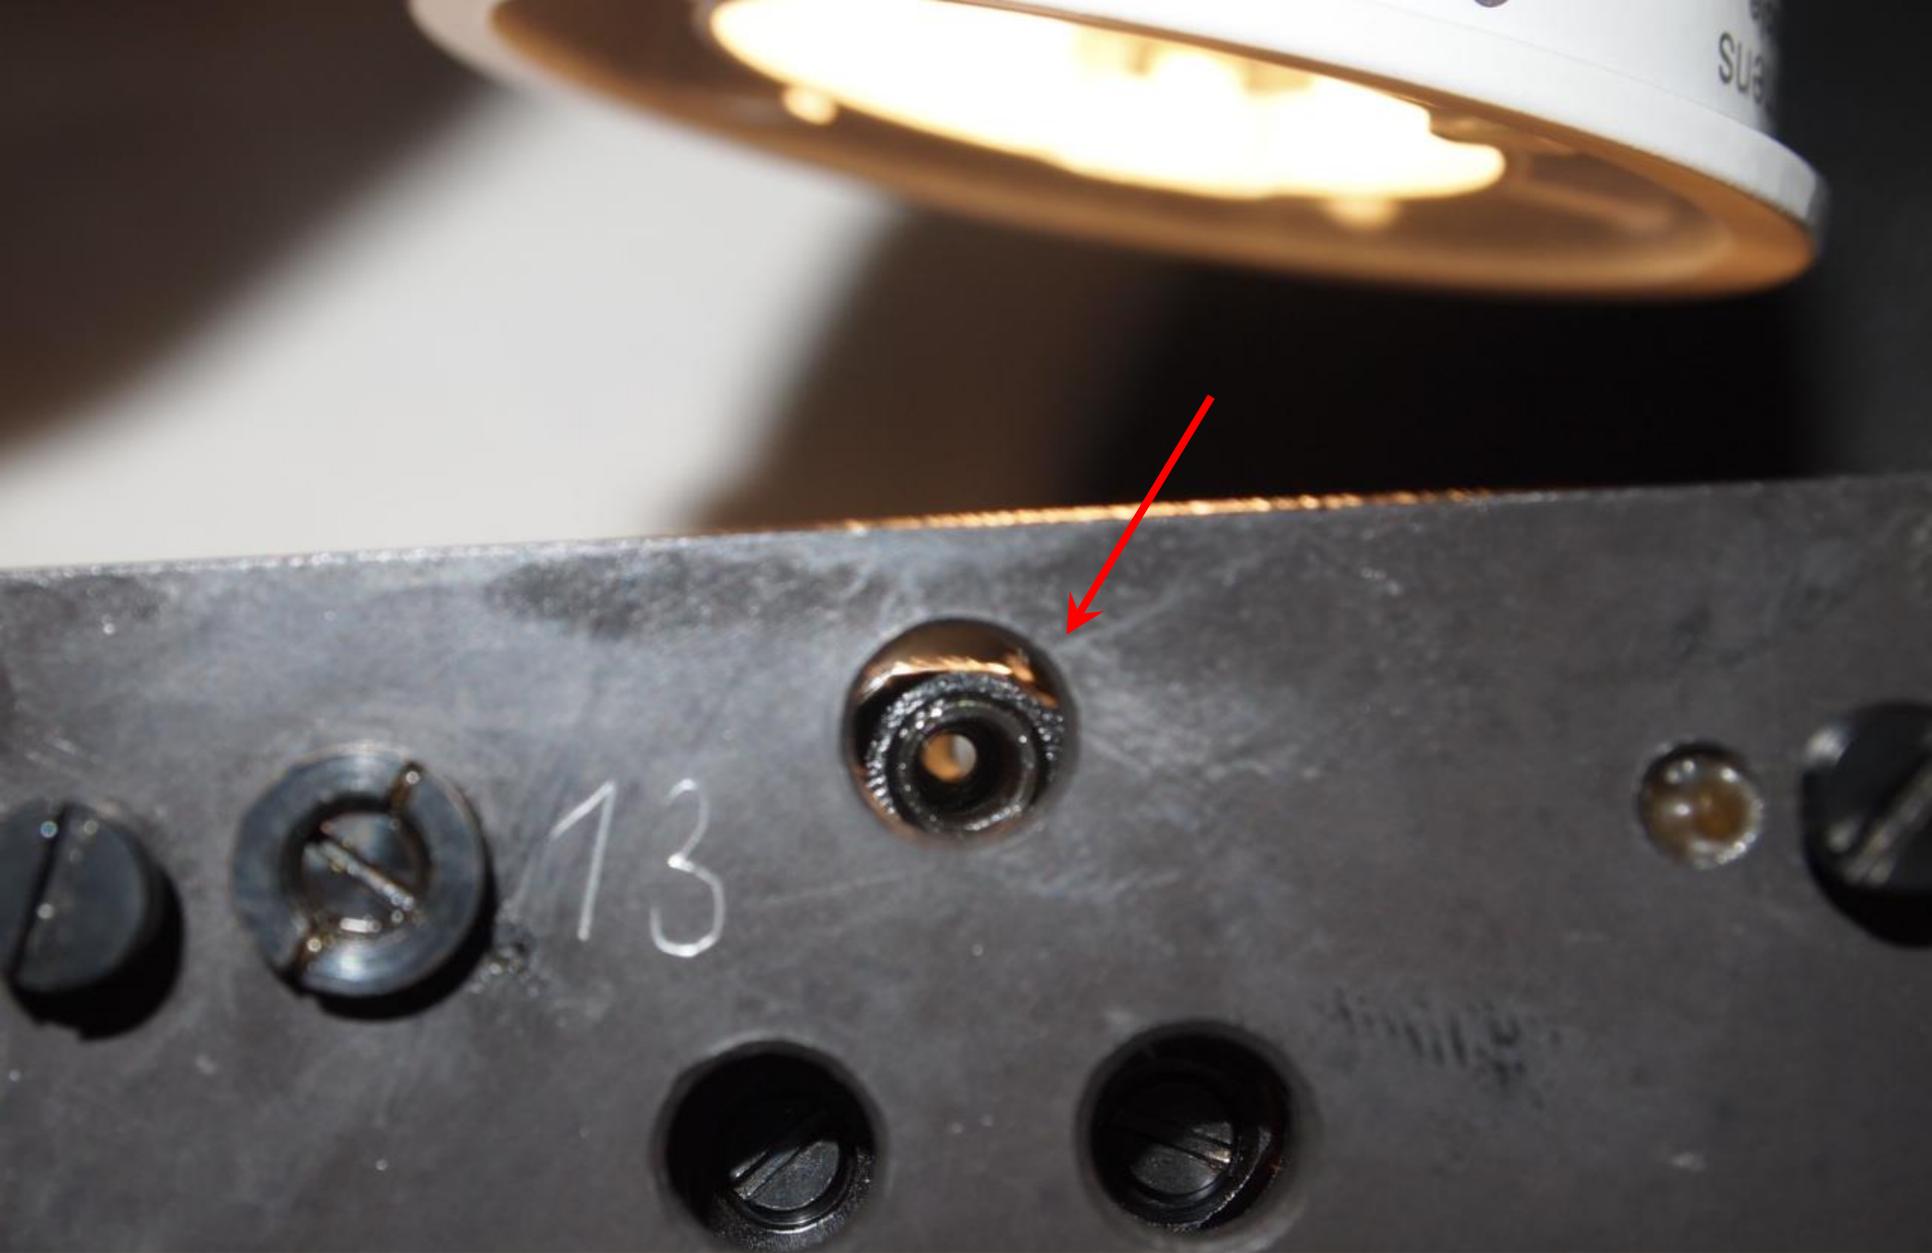
The base plate is off and one can see the bottom of the guide tube. Why this is important will be clear in the next few slides.

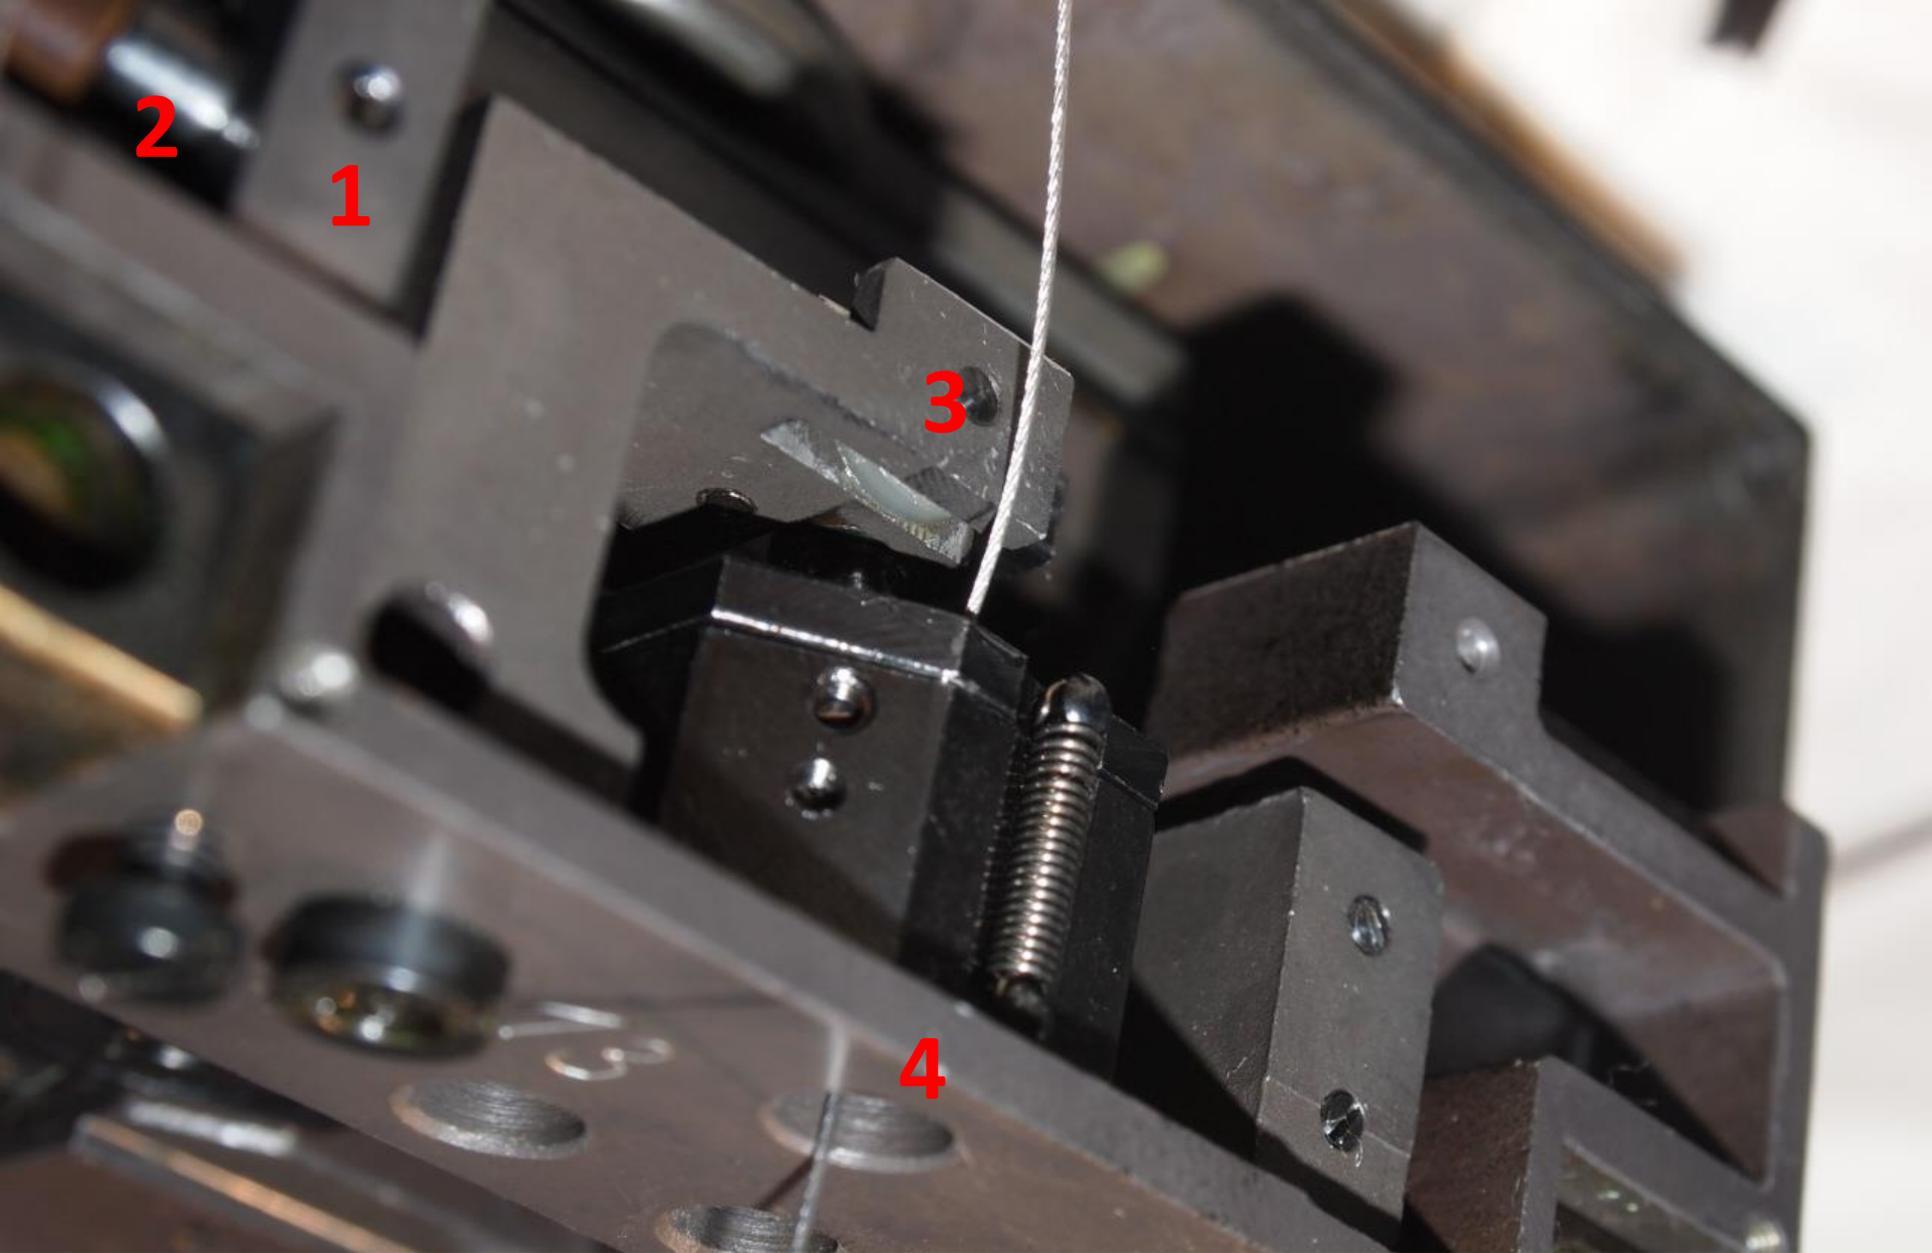
A wire runs from the clamping block (1) at the end of the adjustment actuator (2), over the pulley (3), and down through the focus block rod (4).

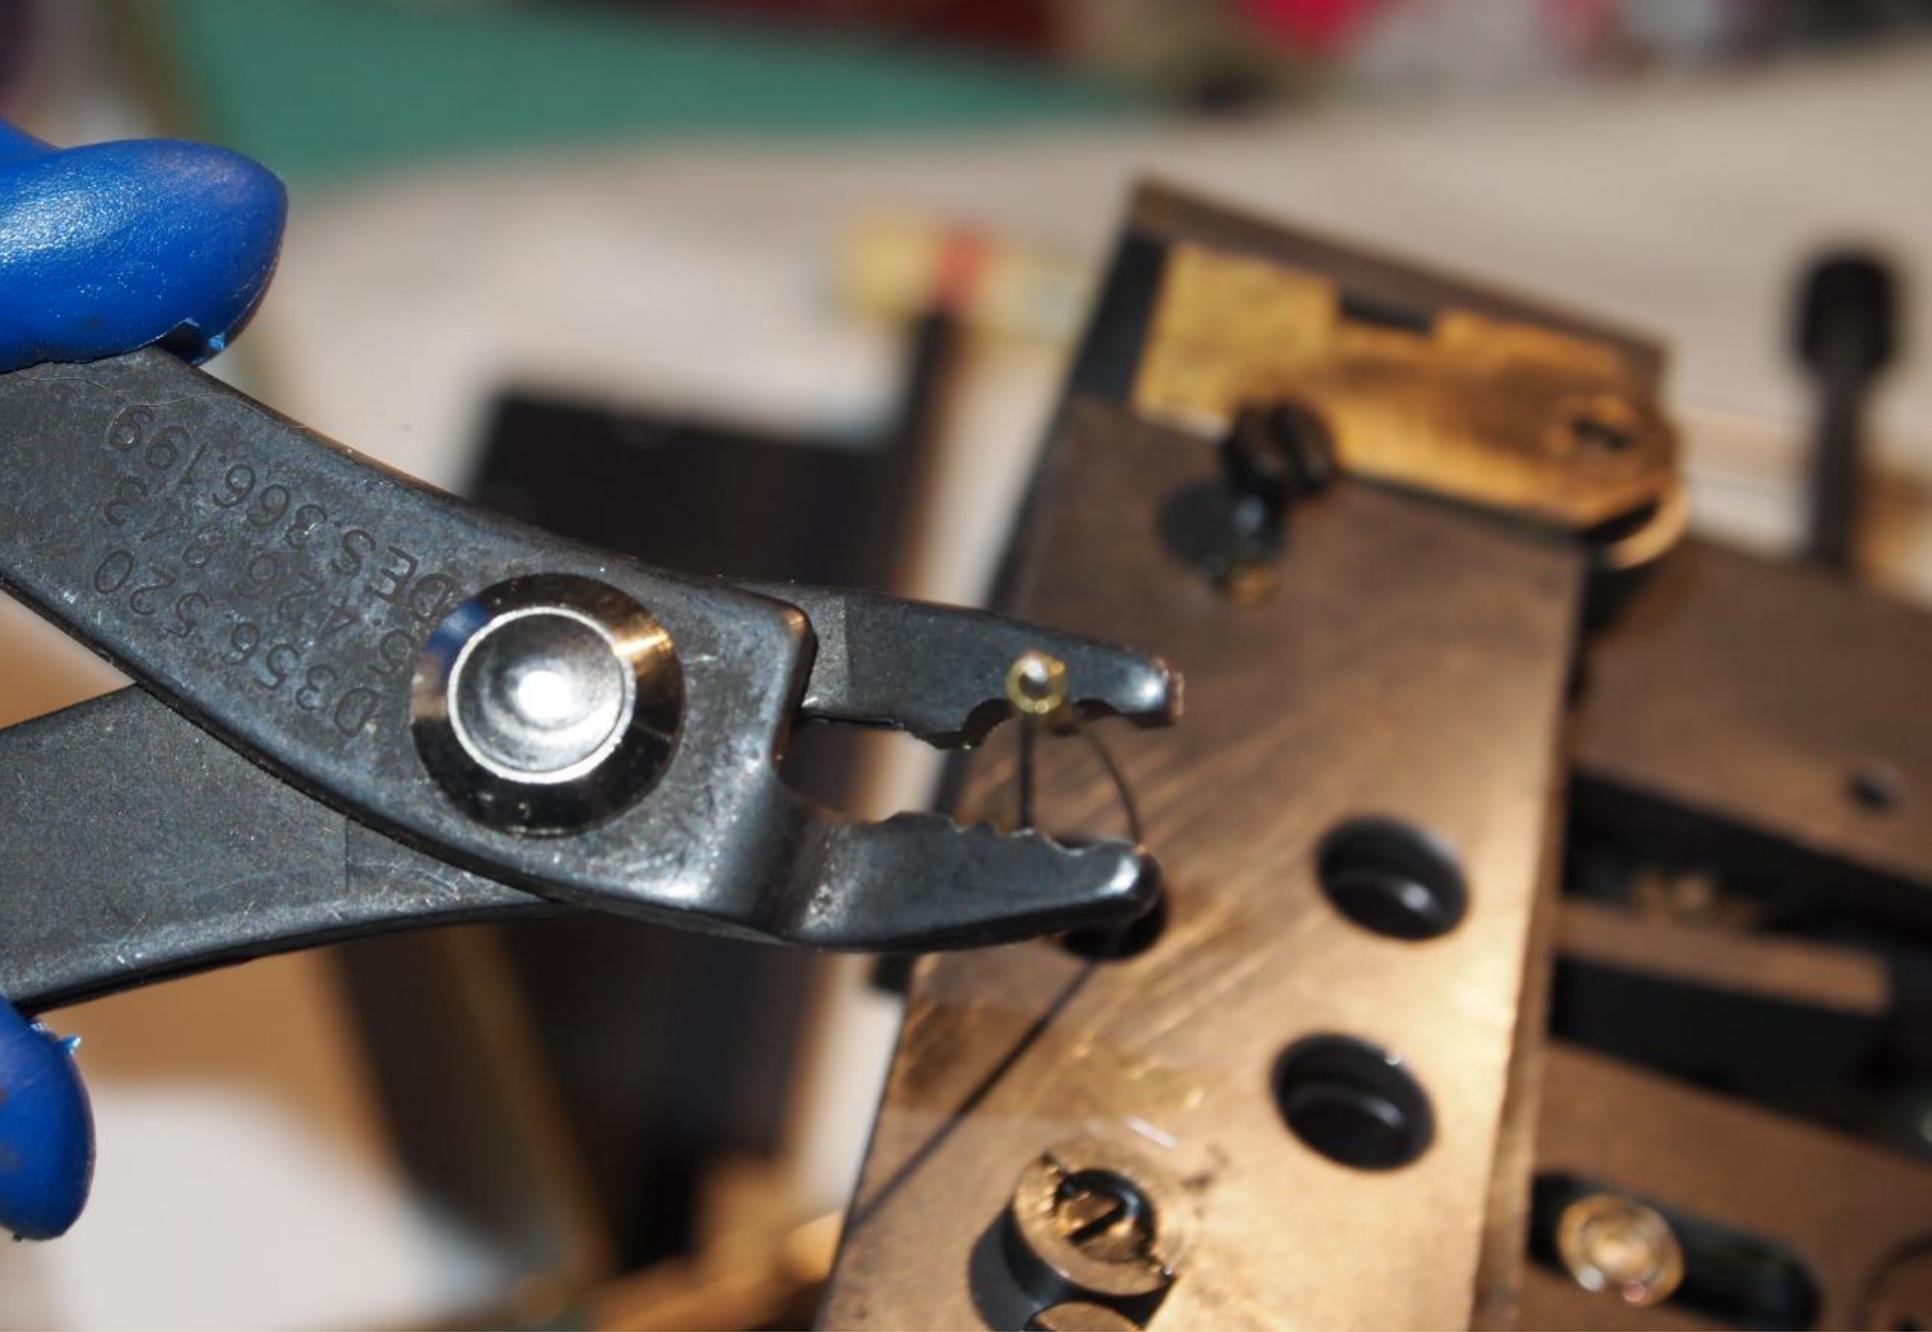
The crimping tool is available where jewelry beading supplies are sold.

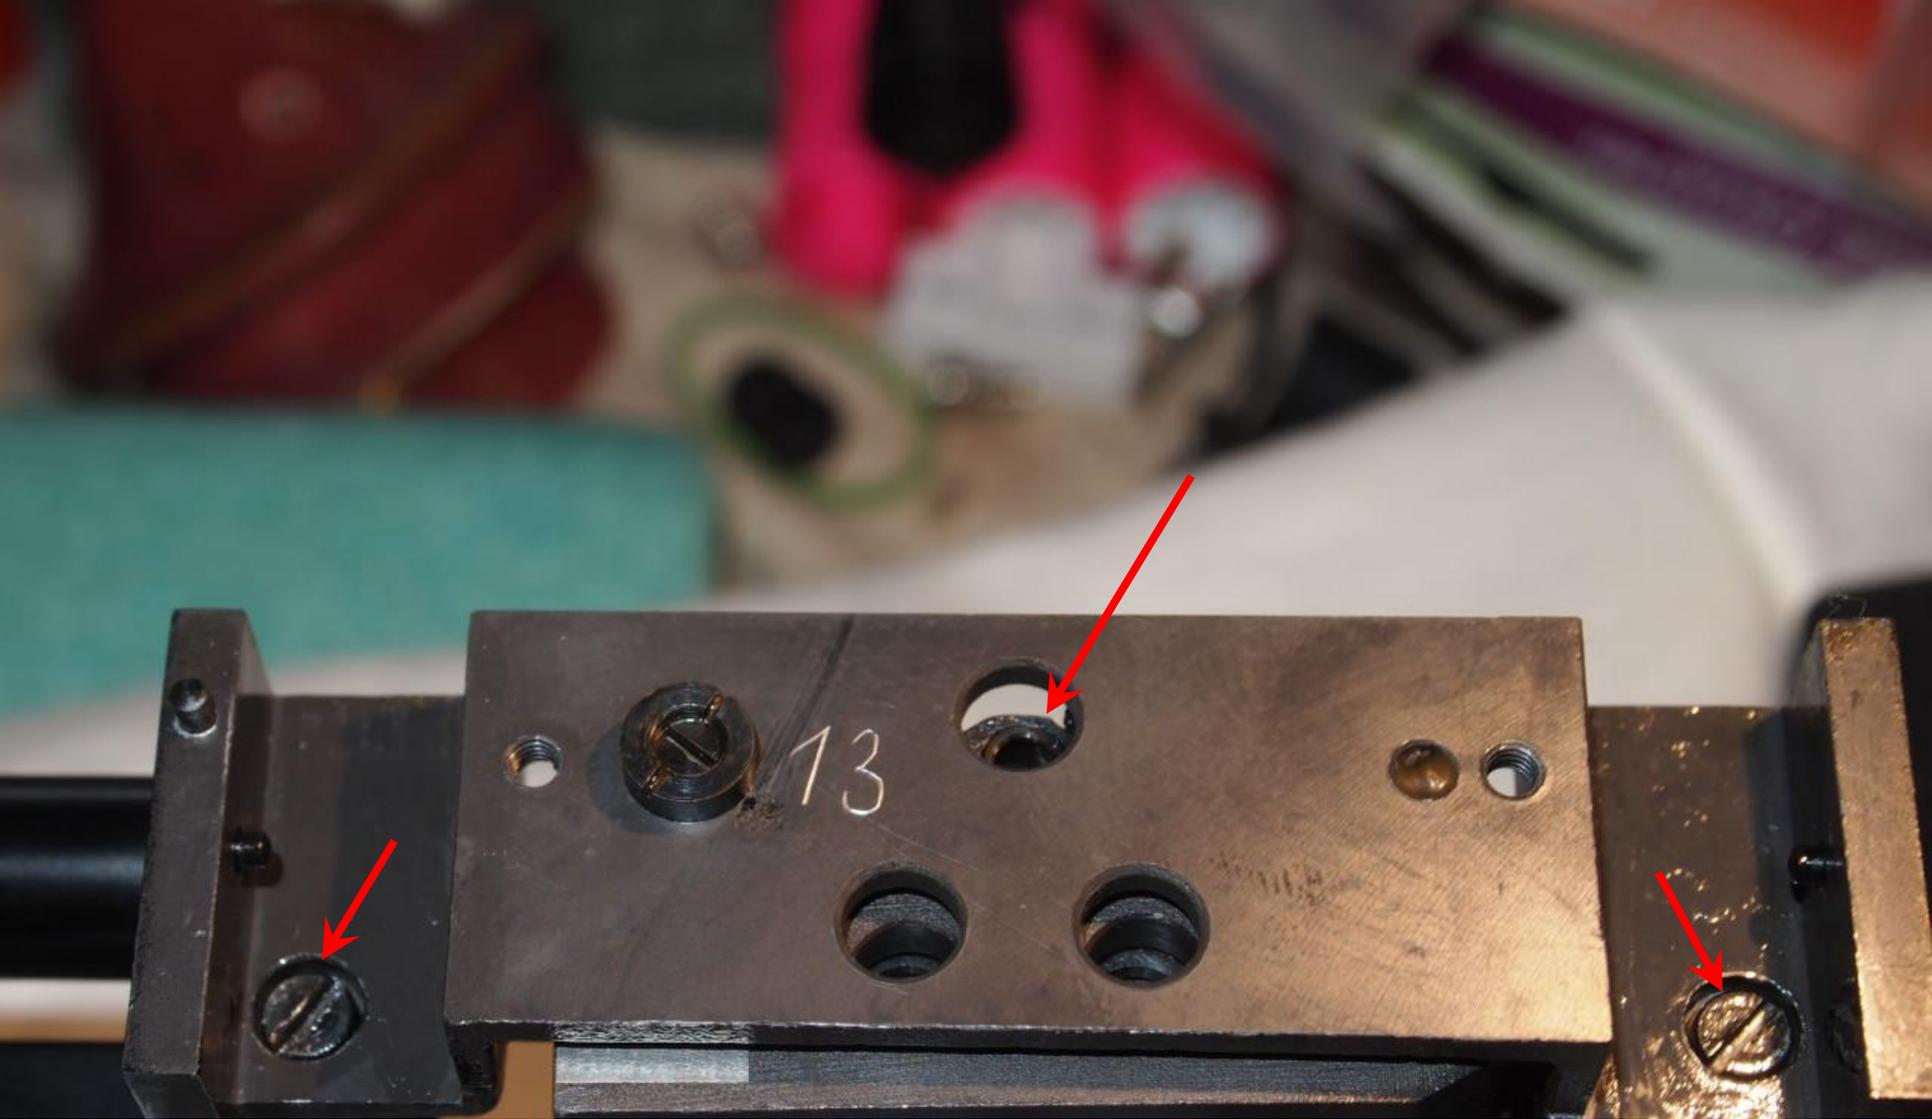
The wire has been pulled into the focus block tube and cannot be seen. The crimp is small enough to fit into the tube and large enough not to slip out the smaller hole at the other end. The two screws in the guide roller slots (small arrows, far left and far right) were not tight, and this was the cause of the misalignment seen earlier. In earlier slides you can see the roller blocks sitting at an angle. They were clamped by the base plate as a result, and the analyzer slider was not properly guided by the spring-loaded roller blocks.

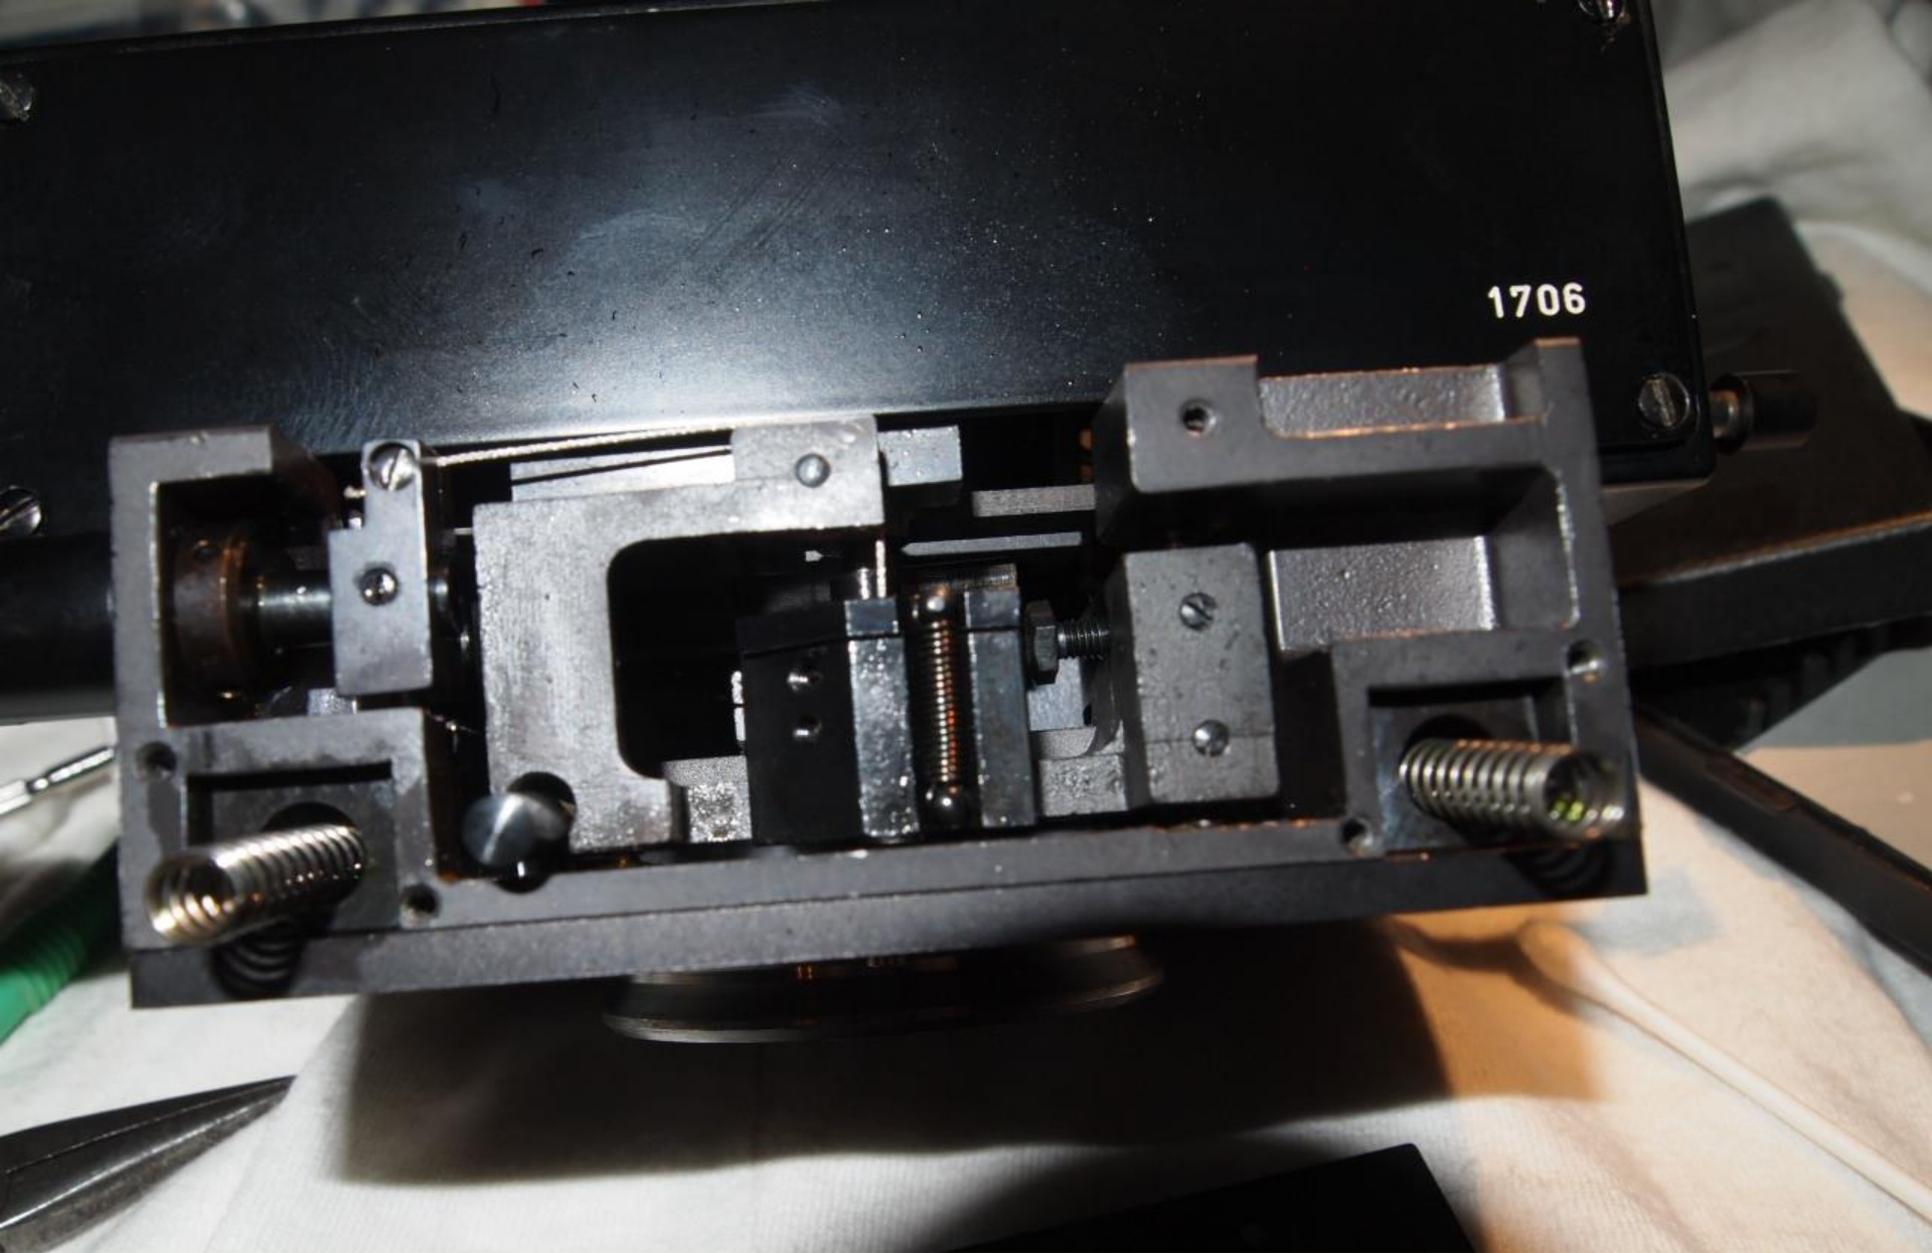
1706

Everything has been cleaned. The springs are back in place. The analyzer slider rollers now move back and forth smoothly, and the base plate fits snugly.

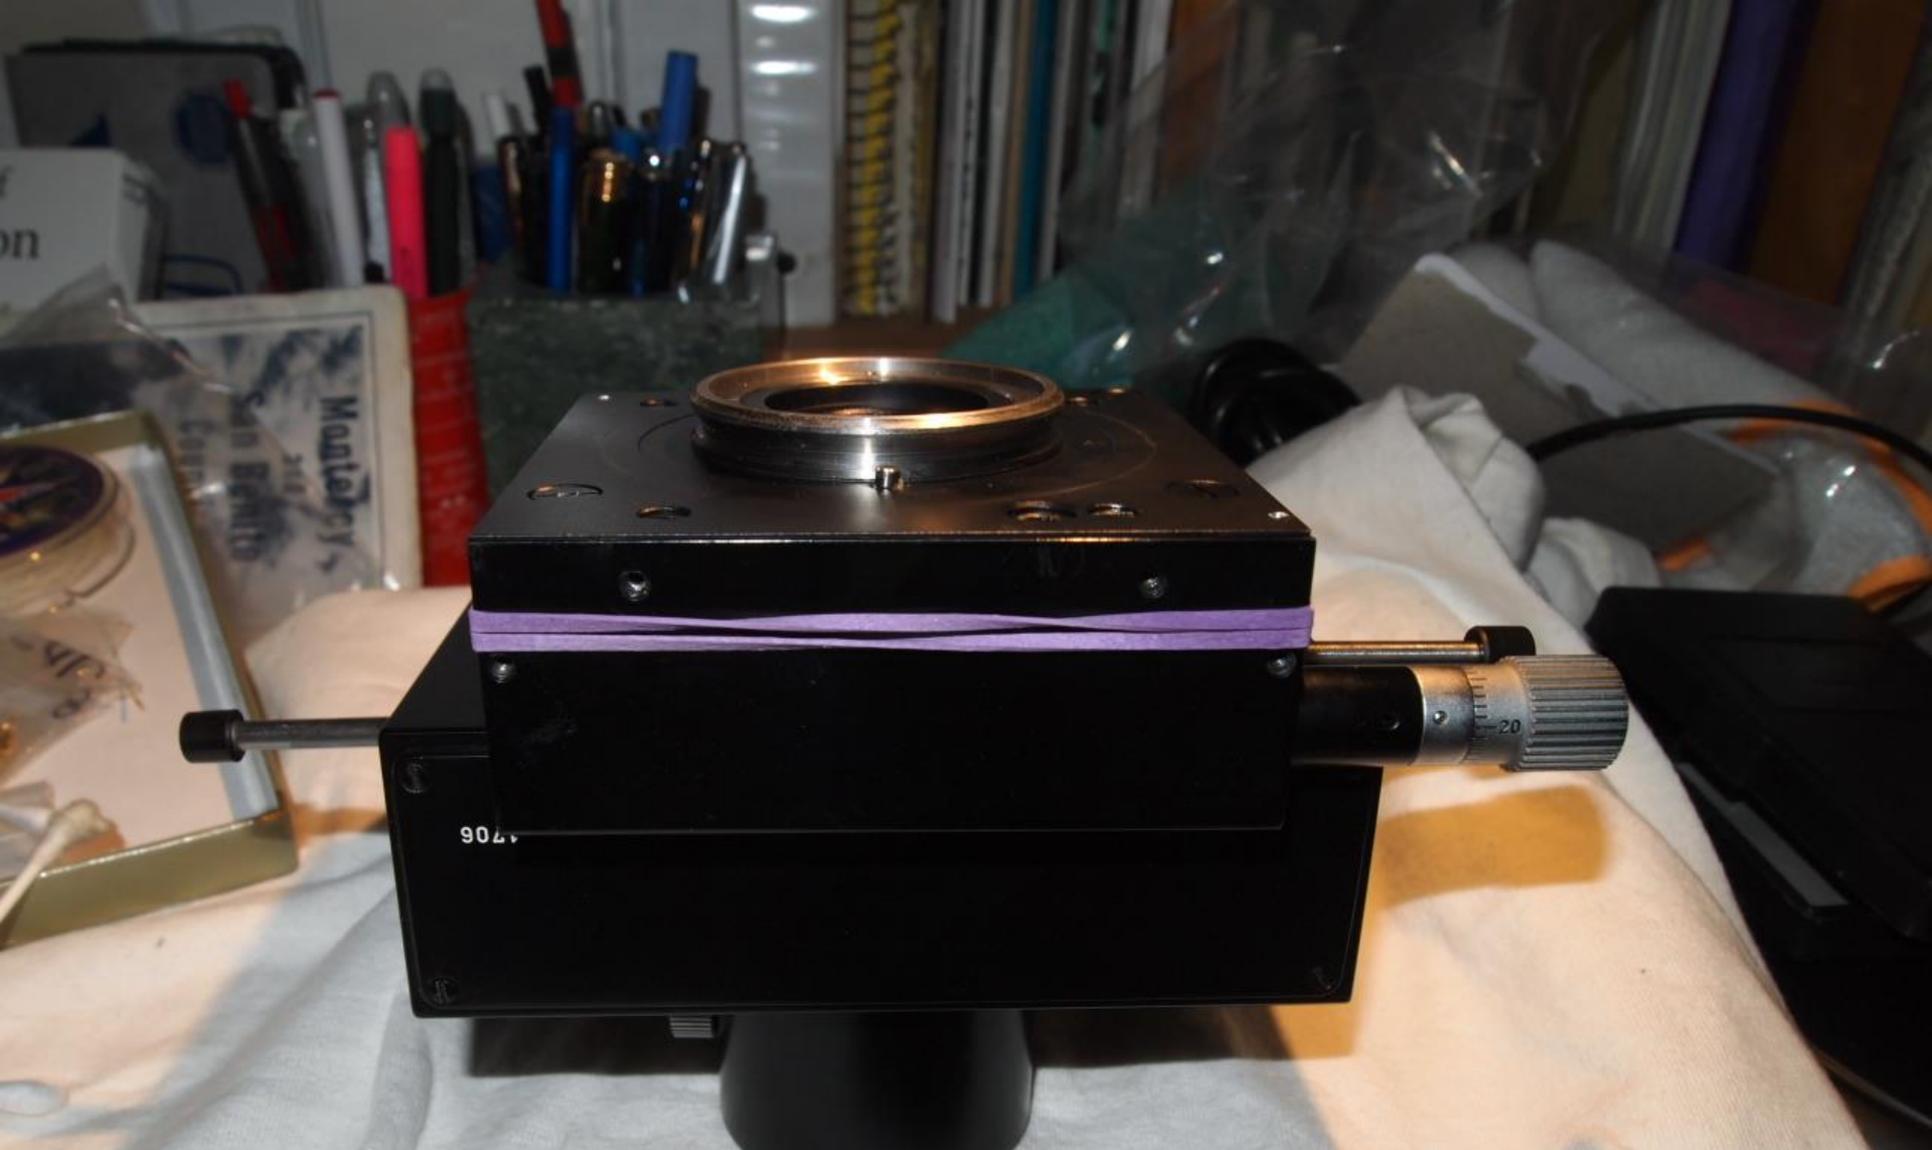
Back to where I started. When I set the cover, I make sure the springs are perpendicular to the cover. This takes a little finesse, because the cover swings into place. Once secured, my hands are free to put in the cover screws easily. Don't loose those screws!! Time for a beer. I'll deal with any alignment problems later.
